## Preliminary Arborist Report

**Sutter Health Joint Venture Cancer Center**  
Oakland, CA

April 2022  
**Revised March 2023**

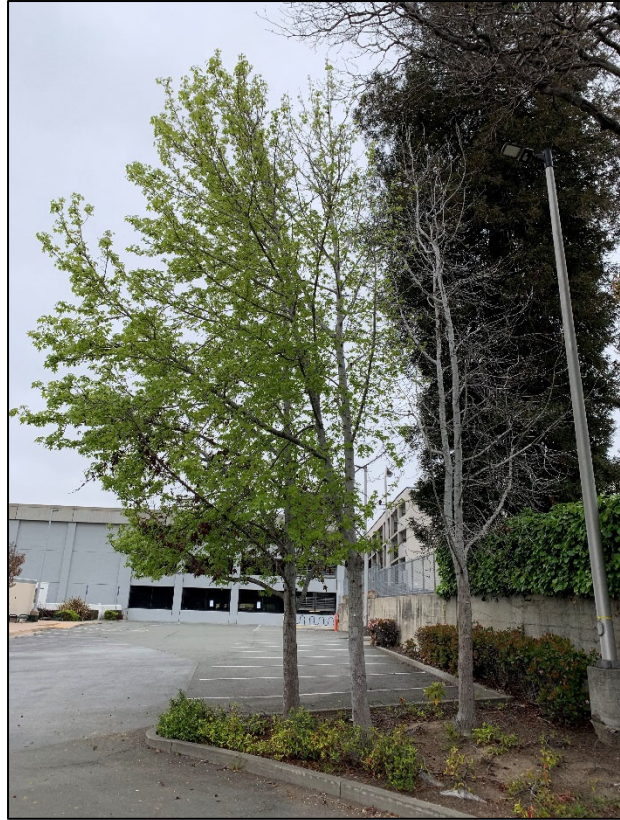
Six sweetgums grew in two planting beds, each containing three trees, located at the S. end of the site (Photo 1). Trees were similarly sized to one another with diameters between 7 to 10 inches. Trees #99 and #101 - 103 were in fair condition while #98 and 100 were in poor condition. All sweetgums had either multiple or codominant branching arising between 6 - 8 feet.

**Photo 1:** Sweetgums #98 – 100 grew in a planting bed on the E. side of the lower-level parking area.

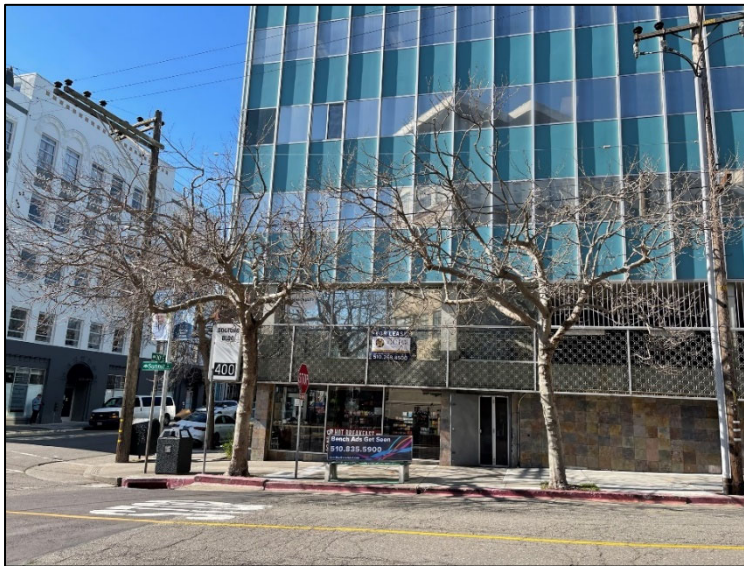
**Photo 2:** London planes #179 and 180 (left – right) were in fair condition. Multiple branches arose from between 9 – 10 feet, creating a low crown beneath overhead electrical utilities.

Four London planes (*Platanus x hispanica*) were in tree wells along Summit Street. Trunk diameters measured either 13 inches (tree #180) or 14 inches (#179, 181, 182), indicating semi-mature development (Photo 2). Trees #179, 180, and 182 were in fair condition with multiple branches arising between 9 – 10 feet above grade. Overhead high-voltage electrical distribution line-clearance pruning resulted in low, densely budding crown profiles. Tree #181 was in poor condition. A previous branch failure left an approximately 5-foot-long tear-out wound on the south side.

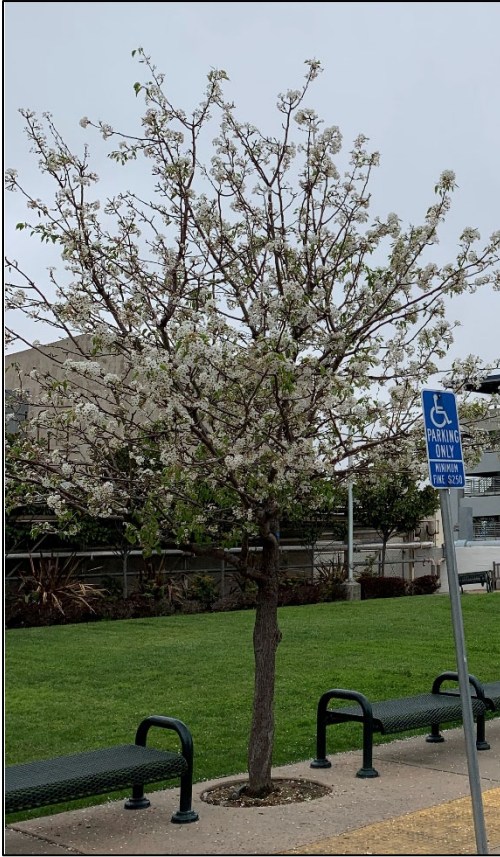
Three Callery pears (#95 - 97) were in a narrow planting bed along the W. side of the lower parking lot (Photo 2). These pears were relatively uniform in size, with diameters ranging from 4 to 6 inches. All three trees were in fair condition with poor form and structure, often with codominant and crossing branching (Photo 2). Multiple attachments arose between 4 and 8 feet.

**Photo 2:** Callery pear #97 exhibited poor form and structure with multiple attachments arising from 6 – 7 feet, codominant branching, and crossing branches throughout the crown.

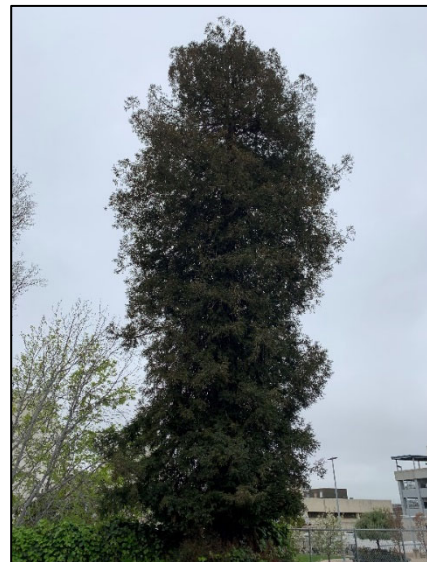
- Coast redwood #86 was in fair condition with a narrow crown and a strong central leader. It had been topped in the past. The trunk was engulfed in ivy (Photo 3).
- Victorian box #87 was in poor condition with pervasive twig and branch dieback throughout the crown.
- Saucer magnolia #90 was in fair condition with poor form and structure due to codominant branch unions, crossing branches, and fusing branches throughout the crown.
- Eastern arborvitae #91 was in fair condition with codominant stems arising from the base and at 2 feet. It was shade suppressed by buildings to the N. and S.
- Red maple #92 in fair condition with branch dieback in the lower crown and good structure.
- Crape myrtle #93 was dead.
- Olive #94 was in fair condition with its base engulfed in reeds. Branch dieback was present in the lower crown.

**Photo 3:** Coast redwood #86 had a narrow crown and had been previously topped. Ivy engulfed the base of the tree.
