MEMORANDUM

Re: Ney Avenue Neighborhood Traffic Calming Study Existing Conditions

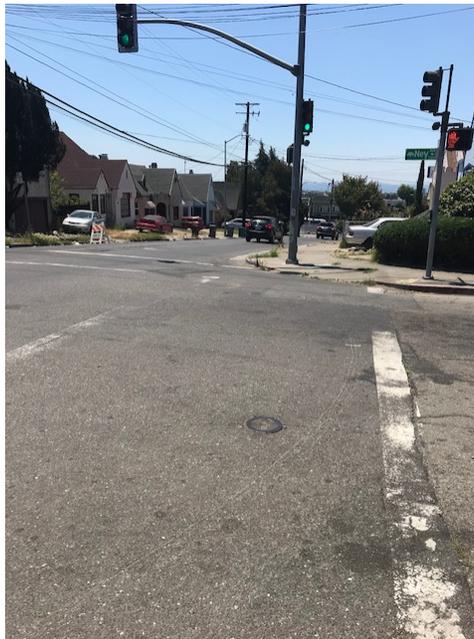
Figure 5: Northeast Corner at Ney Avenue and 73rd Avenue

Ney Avenue at 73rd Avenue is a signalized intersection with faded transverse marked crosswalks on all approaches. Existing, non-compliant curb ramps are installed on every corner. There is 15-20 feet of red curb on each side of every approach. Stop bars are not installed at the intersection and there is a storm drain on the northeast corner.

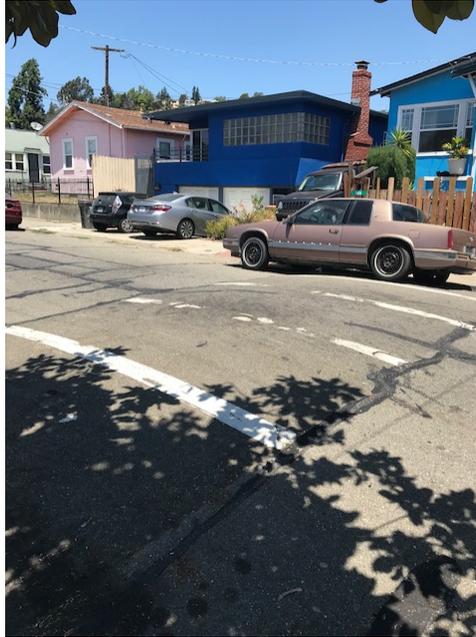
Figure 6: Speed Hump on Ney Avenue Between 73rd Avenue and 75th Avenue

This segment is approximately 400 feet long with a curb-to-curb width of 29 feet. At the time of the field visit 11 of the approximately 30 available parking spaces were being utilized. A handicap parking spot is installed at 1321 Ney Avenue. The spot is marked by a handicap parking sign and blue curb. There is one speed hump about 130 feet from the intersection of Ney Avenue at 75th Avenue with deteriorating striping. The speed hump is 12 feet wide and four and a half inches high at the center.

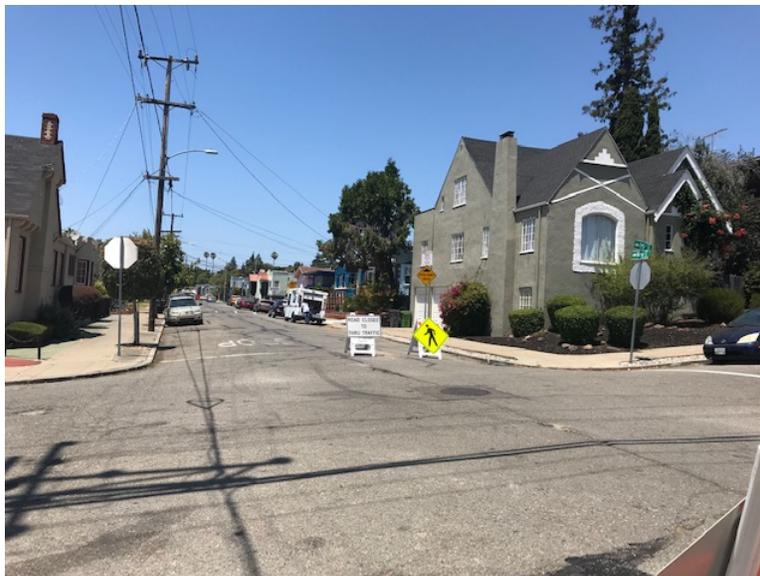
Figure 7: Southeast Corner at Ney Avenue and 75th Avenue

Ney Avenue at 75th Avenue is a four-way stop controlled intersection with no existing marked crosswalks or curb ramps. Both the northeast and southeast corners have storm drains. A fire hydrant is located on the southeast corner and a manhole is located in the center of the intersection. All approaches have a fading stop bar and the northern leg is the only approach with red curb along both sides.

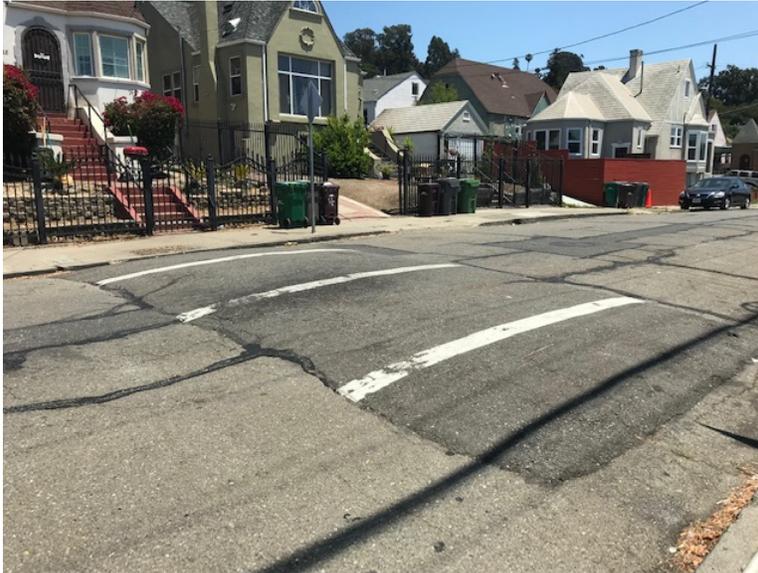
Figure 8: Speed Hump on Ney Avenue Between 75th Avenue and 76th Avenue

This block is approximately 400 feet long with a curb-to-curb width of 30 feet. At the time of the field visit 14 of the approximate 30 parking spaces were being utilized. A speed hump in satisfactory condition is installed about 165 feet north of the intersection of Ney Avenue at 76th Avenue. The speed hump is 12 feet wide and three and a half inches high at the center. There is a manhole and storm drain at 7535 and 7534 Ney Avenue, respectively.

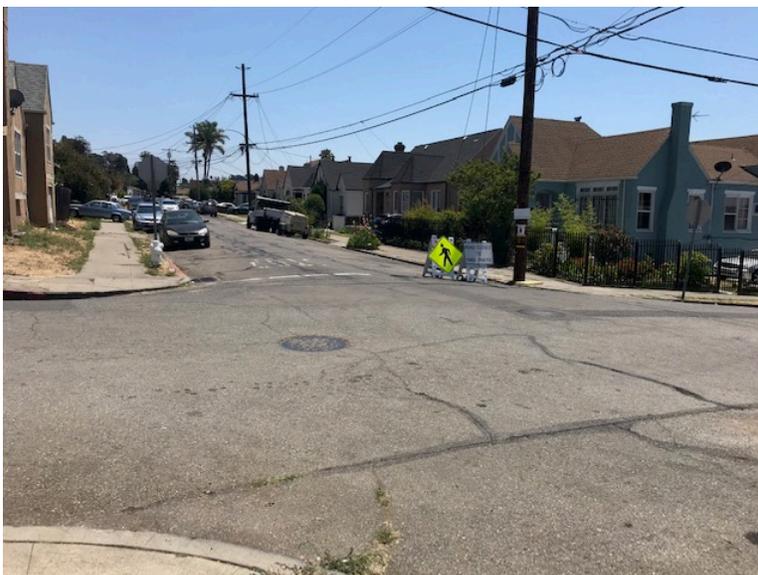
Figure 9: Northeast Corner at Ney Avenue and 76th Avenue

Ney Avenue at 76th Avenue is a four-way stop controlled intersection with no existing marked crosswalks. The northwest corner has an existing, likely compliant curb ramp. The remaining corners do not have curb ramps. There are seven to 20 feet of red curb on each side of every approach. All approaches have stop bars and storm drains are installed on the northeast and southeast corners. Additionally, there are two manholes in the intersection and a fire hydrant on the southeast corner.

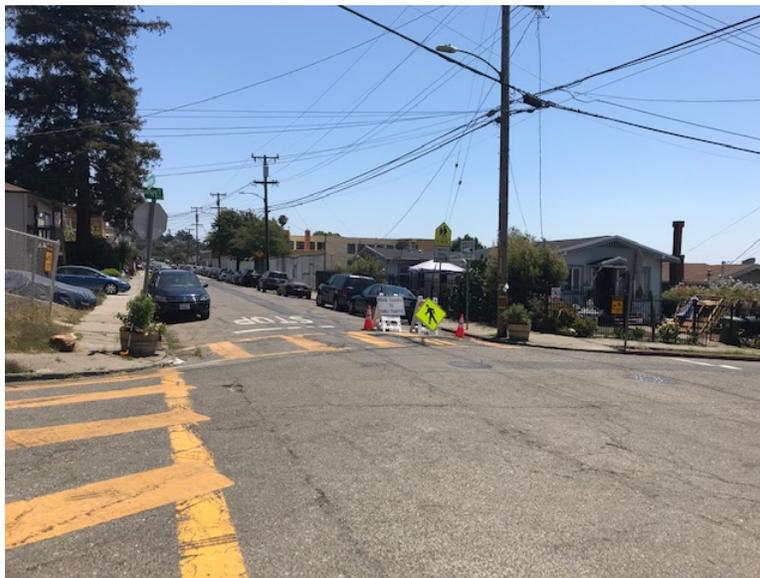
Figure 10: Northeast Corner at Ney Avenue and Parker Avenue

Ney Avenue at Parker Avenue is a four-way stop controlled intersection with yellow continental marked crosswalks on the east and south approaches. Curb ramps are missing at the intersection. There are 10 to 20 feet of red curb on each side of every approaches. All approaches have stop bars. Storm drains are installed on the northeast and southeast corners. Additionally, there are three manholes in the intersection and a fire hydrant on the southeast

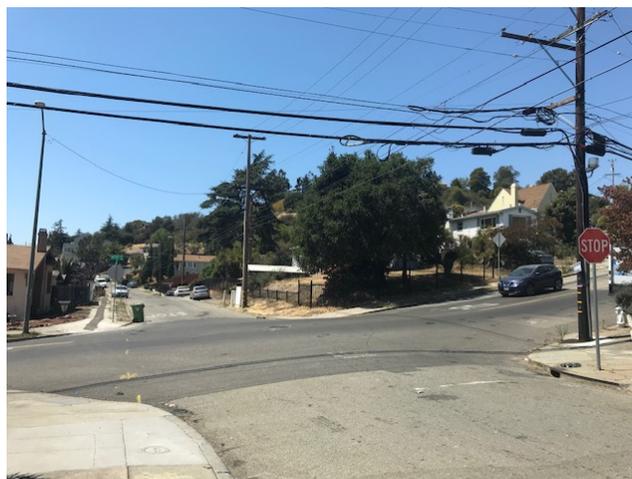
Figure 16: Southwest Corner at Outlook Avenue and 73rd Avenue

The intersection of Outlook Avenue and 73rd Avenue is two-way stop controlled where Outlook Avenue is stop controlled. There are stop bars on both Outlook approaches, though the south stop bar is very faded. Crosswalks are not marked at the intersection. There are existing, likely compliant curb ramps at each corner. Both the northeast and southeast corners have storm drains. There is 26 feet of faded red curb on east approach on the south side. There are multiple manholes and utilities throughout the intersection.

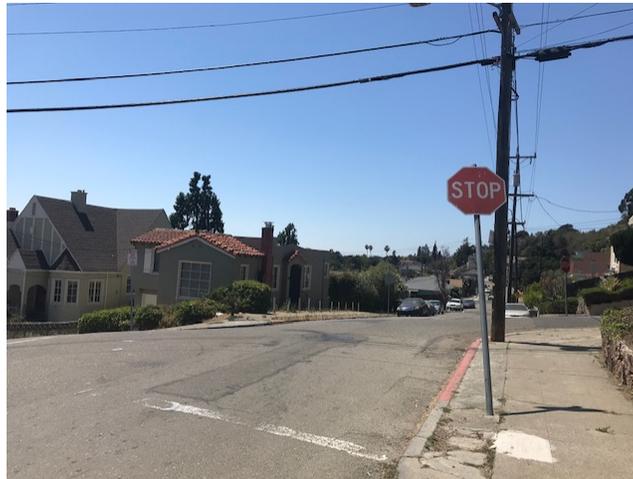
Figure 17: Southeast Corner at Outlook Avenue and 75th Avenue

Outlook Avenue at 75th Avenue is a skewed intersection that operates as an all-way stop control. Each approach has stop bars, though the south stop bar is faded. Curb ramps are missing and crosswalks are not marked at the intersection. There are two manholes along Outlook Avenue. Each approach has 8 to 20 feet of red curb at the intersection.

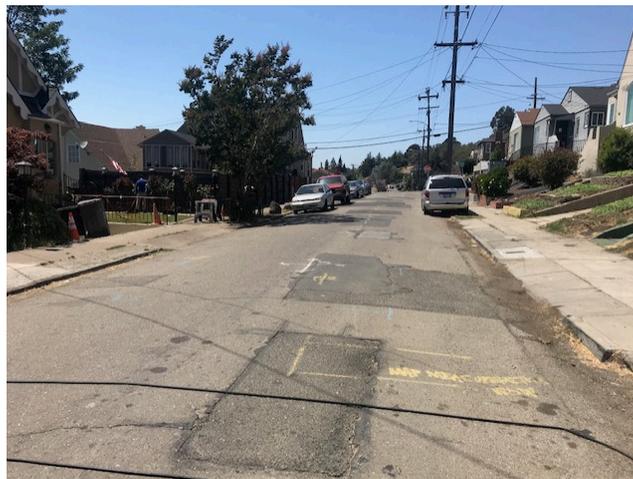
Figure 18: Outlook Avenue Between 75th Avenue and 76th Avenue Looking Northbound

This segment is approximately 370 feet long with a curb-to-curb width of 23 feet. During the site visit 14 of the approximate 30 parking spaces available in this section were being utilized. There is one speed hump located approximately 150 feet north of 76th Avenue. The speed hump is in satisfactory condition and measures 12 feet wide and three inches high at the center. There is one manhole on the south side of the speed hump and one manhole and storm drain at 7537 Outlook Avenue. Alta staff noticed multiple cars parked on the sidewalk.

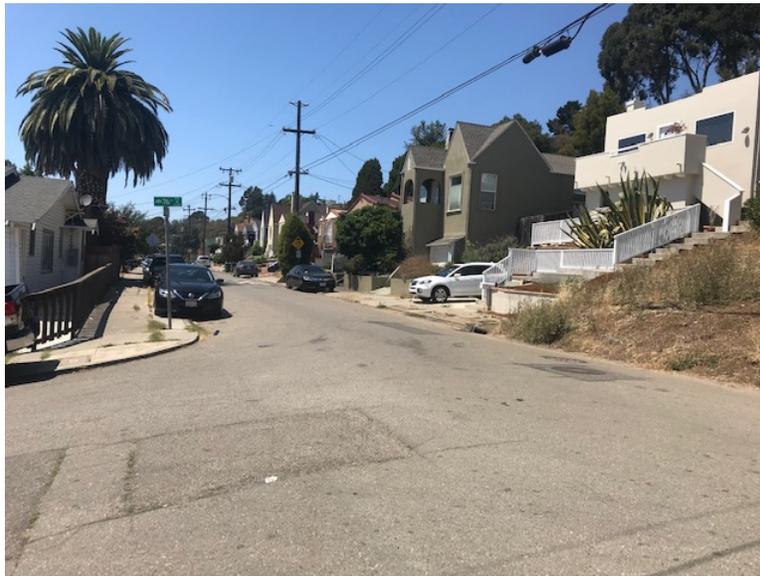
Figure 19: Southwest Corner at Outlook Avenue and 76th Avenue

Outlook Avenue at 76th Avenue is stop controlled for 76th Avenue. Marked crosswalks, stop bars, and red curbs are not installed at the intersection. There are multiple manholes throughout the intersection and a storm drain on the northeast corner. Curb ramps are missing on all corners.

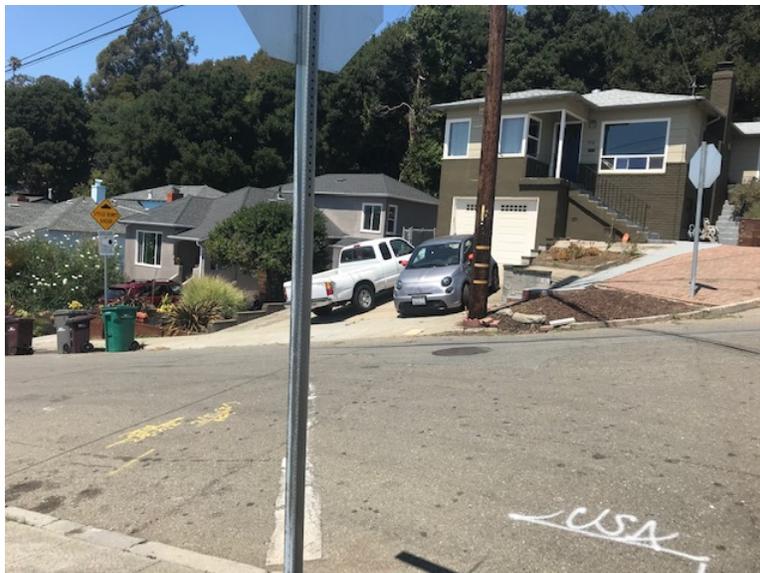
Figure 20: Northwest Corner at Outlook Avenue and Parker Avenue Looking Northbound

This segment is approximately 600 feet long with a curb-to-curb width of 23 feet. During the site visit 18 of the approximate 50 total parking spaces being utilized. There are two speed humps placed 200 feet apart, beginning approximately 15 feet south of the intersection of Outlook Avenue at 76th Avenue. One speed hump is in satisfactory condition while the other has fading linework. Each speed hump measures 12 feet wide and two to three inches high at the center. There are manholes at 7718, 7701, 7644, and 7621 Outlook Avenue and a utility cover at 7724 Outlook Avenue.

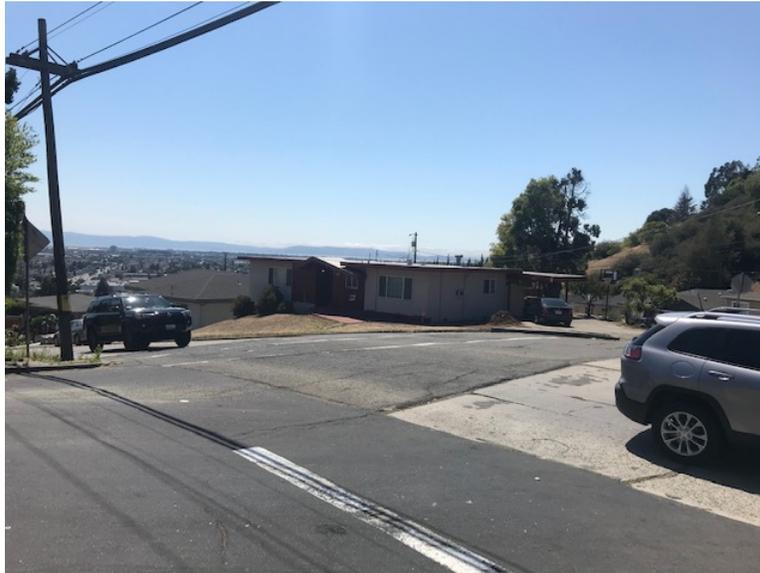
Figure 21: Southeast Corner at Hillmont Avenue and 73rd Avenue

The intersection of Hillmont Avenue and 73rd Avenue is stop controlled with Hillmont Avenue being stop controlled. There is one marked transverse marked crosswalk across the west approach of 73rd Avenue. Curb ramps are missing on all corners. Alta staff noted that the southwest corner has poor visibility and witnessed a pedestrian waiting for four cars to pass until they were able to safely cross the western approach. There are multiple manholes at this intersection.

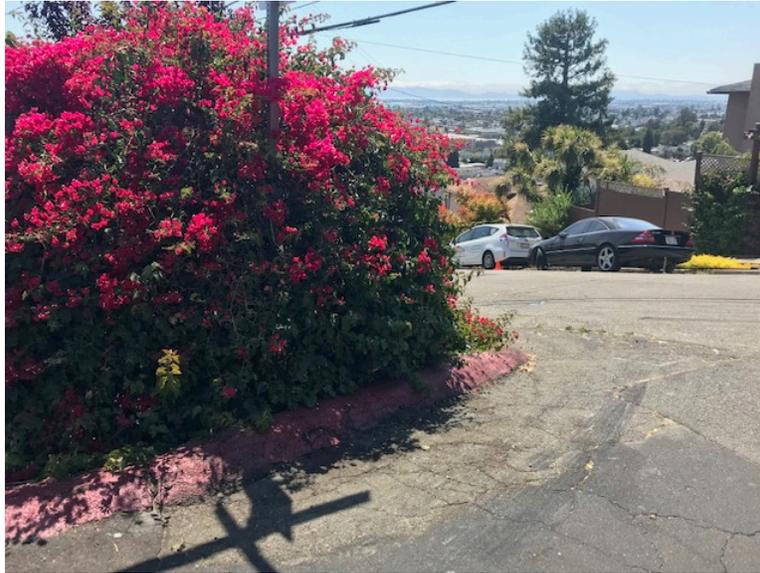
Hillmont Avenue at 75th Avenue is a T-intersection and stop signs are not installed for any of the approaches. Visible tire marks were observed from vehicles making sharp turns. Stop bars, existing marked crosswalks, and storm drains are not installed at the intersection. There are ten feet of red curb on the west approach to the intersection and 25 feet on the south approach. Curb ramps are missing on all corners.

Figure 23: Poor Visibility at Southwest Corner at Hillmont Avenue and 75th Avenue

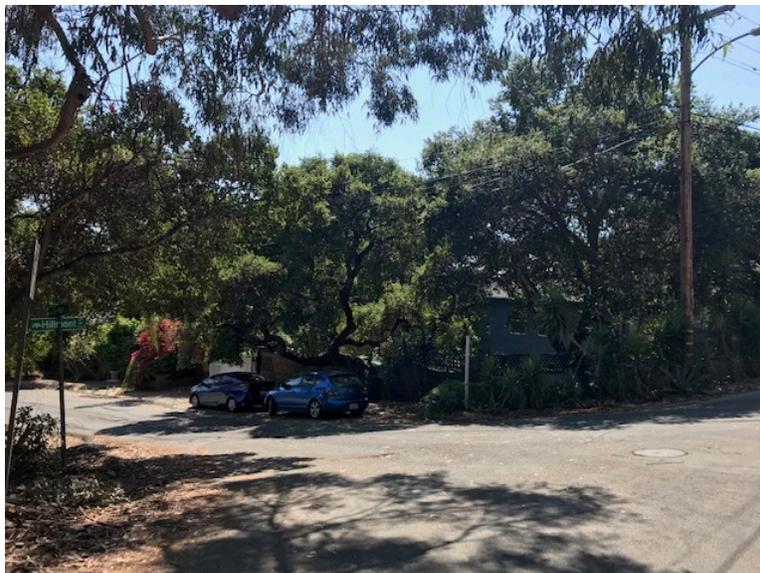
Figure 24: Southwest Corner at Hillmont Avenue and Parker Avenue

Parker Avenue at Hillmont Drive is a T-intersection and stop signs are not installed for any of the approaches. At the intersection, Parker Avenue begins a steep and curved decline towards Ney Avenue. Stop bars, existing marked crosswalks, curb ramps, and storm drains are not installed at the intersection. There are multiple manholes in this intersection.

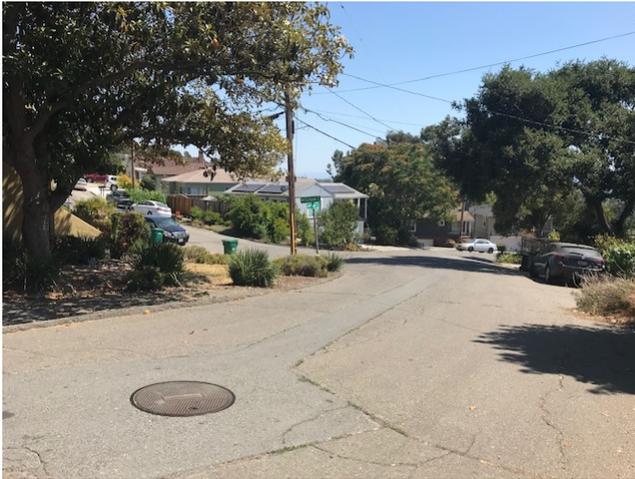
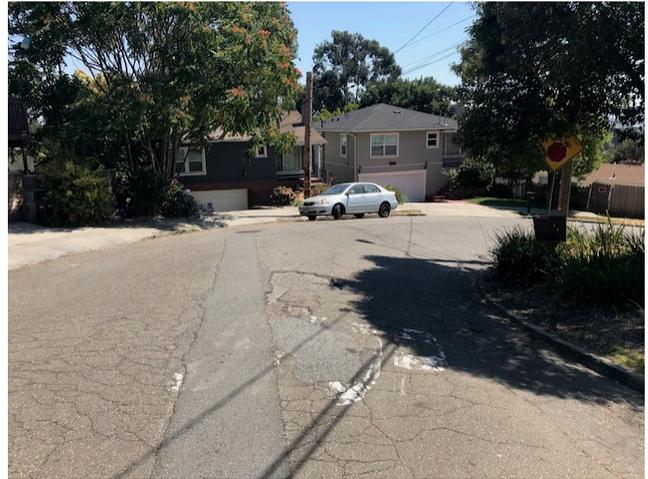
This segment is approximately 550 feet long with a width that ranges from 17 feet to 30 feet. Between Hillmont Avenue and Outlook Avenue East, Parker Avenue is narrow with no defined parking and rolled curb. The pavement is in poor condition as the street approaches Outlook Avenue. Throughout the entire segment, Alta staff noted three parked cars. As the road approaches Outlook Avenue West, there are faded stop warning and deceleration pavement markings.

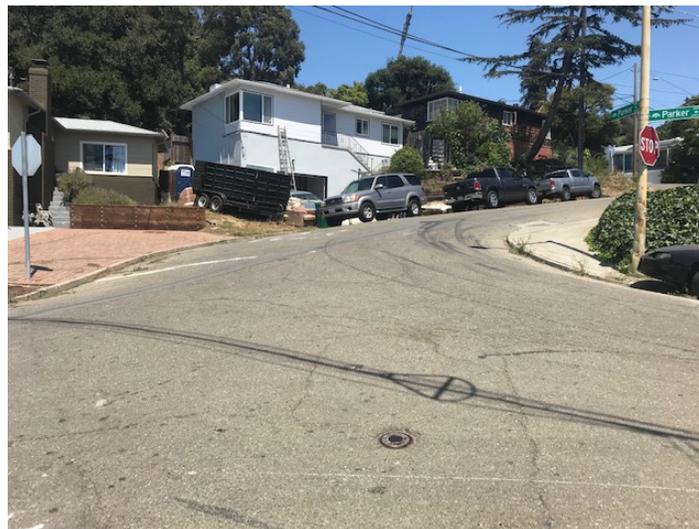
Figure 27: Northwest Corner at Parker Avenue and Outlook Avenue West

Outlook Avenue East at Parker Avenue is a wide, uncontrolled intersection with one manhole and storm drains at the southeast and southwest corners. Stop bars, existing marked crosswalks, curb ramps, and storm drains are not installed at the intersection. Outlook Avenue West at Parker Avenue is a three-way stop-controlled intersection. At this intersection, Parker Avenue bends south at a steep down grade towards Ney Avenue. Alta staff noted poor visibility at Parker Avenue and Outlook Avenue West on the southeast corner and a wide curb radius on the Northeast corner. There is a manhole on the southwest corner and utility poles on the southeast and northeast corners. Stop bars, existing marked crosswalks, curb ramps, and storm drains are not installed at the intersection

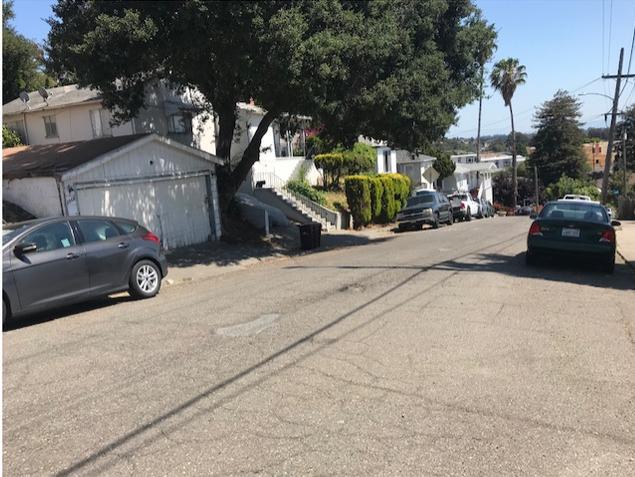
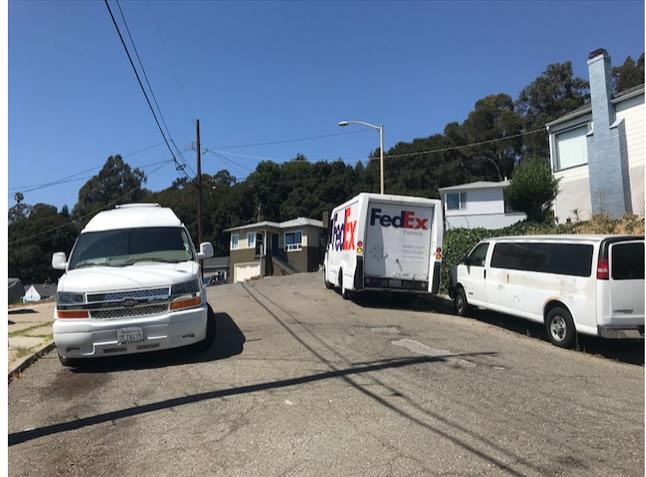
Parker Avenue, between Outlook Avenue West and Ney Avenue, is approximately 550 feet long with a curb-to-curb width of 29 feet. 19 of the approximate 20 total parking spaces were being utilized during the field visit. As the road approaches Outlook Avenue West there are faded “Stop Ahead” pavement markings.

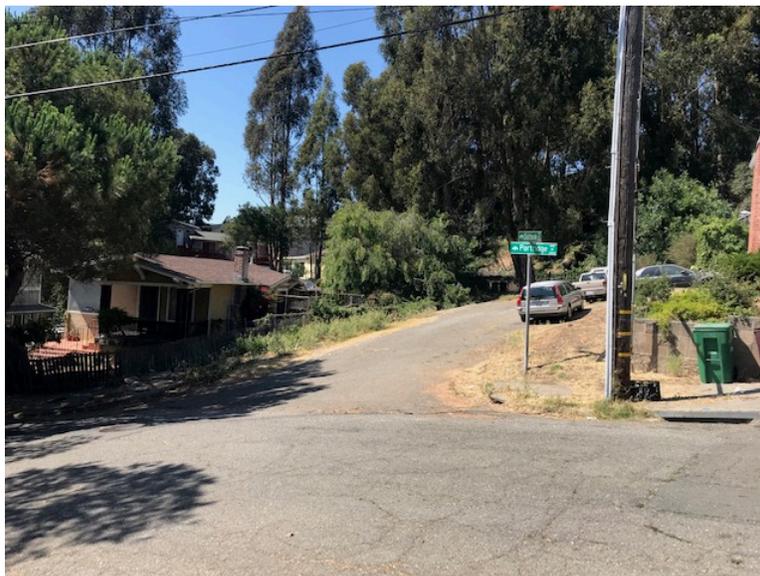
Figure 31: Southeast Corner at Partridge Avenue Between and Outlook Avenue

Partridge Avenue at Outlook Avenue is an uncontrolled, three-legged intersection. Pavement markings and curb paint are not installed for any approach and the curb and pavement at the crossing of Outlook Avenue is in very poor condition. Curb ramps are missing at all corners.

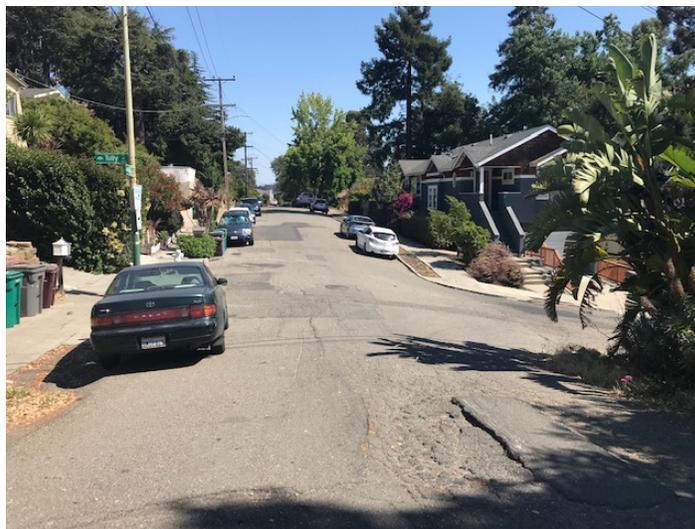
Figure 34: Hillmont Drive at Tully Place Southbound

Tully Place at Hillmont Drive is a T-intersection that is uncontrolled without existing marked crosswalks or curb ramps. The northwest corner has overgrown landscaping and the east side of the intersection has two driveways and a fire hydrant. Storm drains are installed on the southwest and southeast corners of the intersection and a manhole is installed in the center of the intersection.
