# Head Royce School Planned Unit Development Permit (PUD) Project

## Draft Environmental Impact Report Technical Appendices 8A through 16B

Lead Agency:  
City of Oakland

Prepared by:  
Lamphier-Gregory

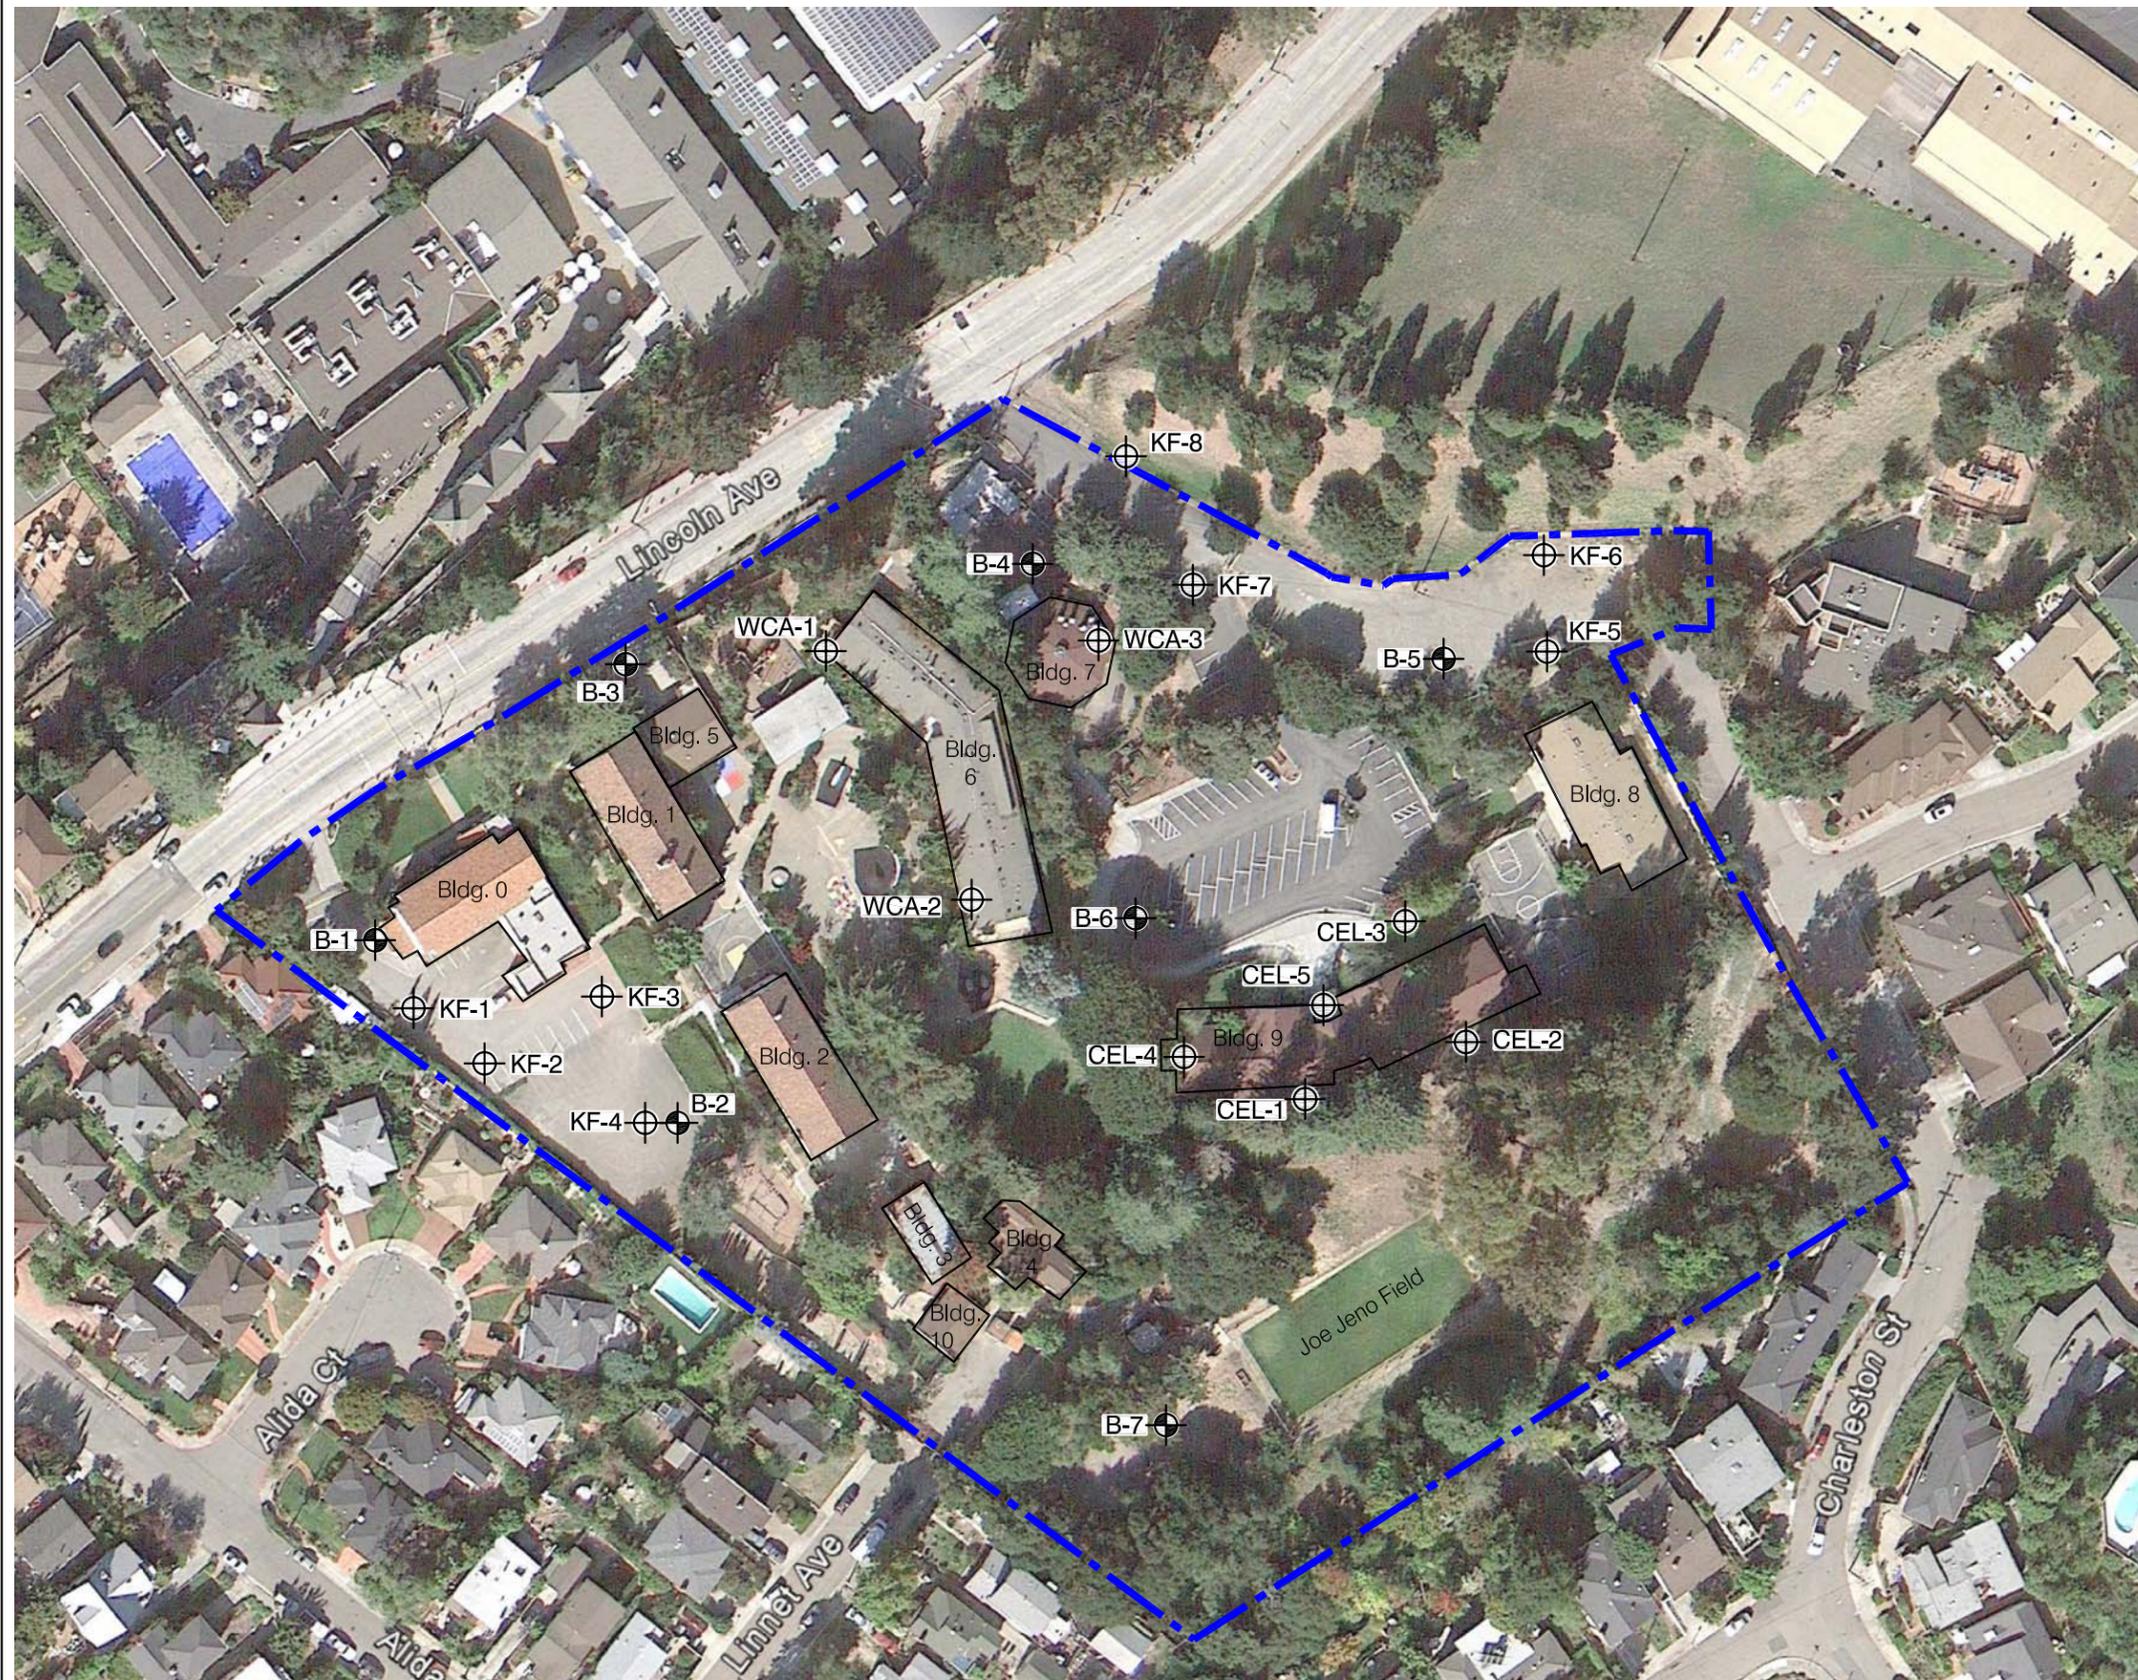
Figure 1

- EXPLANATION**
- B-1 Approximate location of exploratory boring by Rockridge Geotechnical, Inc., April 2012
  - CEL-1 Rough location of exploratory boring by Consolidated Engineering Laboratories, September 1998
  - KF-1 Approximate location of exploratory boring by Kleinfelder, December 2002
  - WCA-1 Rough location of exploratory boring by Woodward, Clyde and Associates, 1957
  - Approximate existing building footprint
  - Approximate limits of subject property

We further investigated the subsurface conditions at the site on April 13, 2012 by drilling seven test borings, designated as B-1 through B-7, at the approximate locations shown on Figure 2. Prior to beginning our field investigation, we obtained a drilling permit from the Alameda County Public Works Agency (ACPWA) and contacted Underground Service Alert (USA) to notify them of our work, as required by law. We also retained Precision Locating, LLC, a private utility locator, to check that the boring locations were clear of existing utilities.

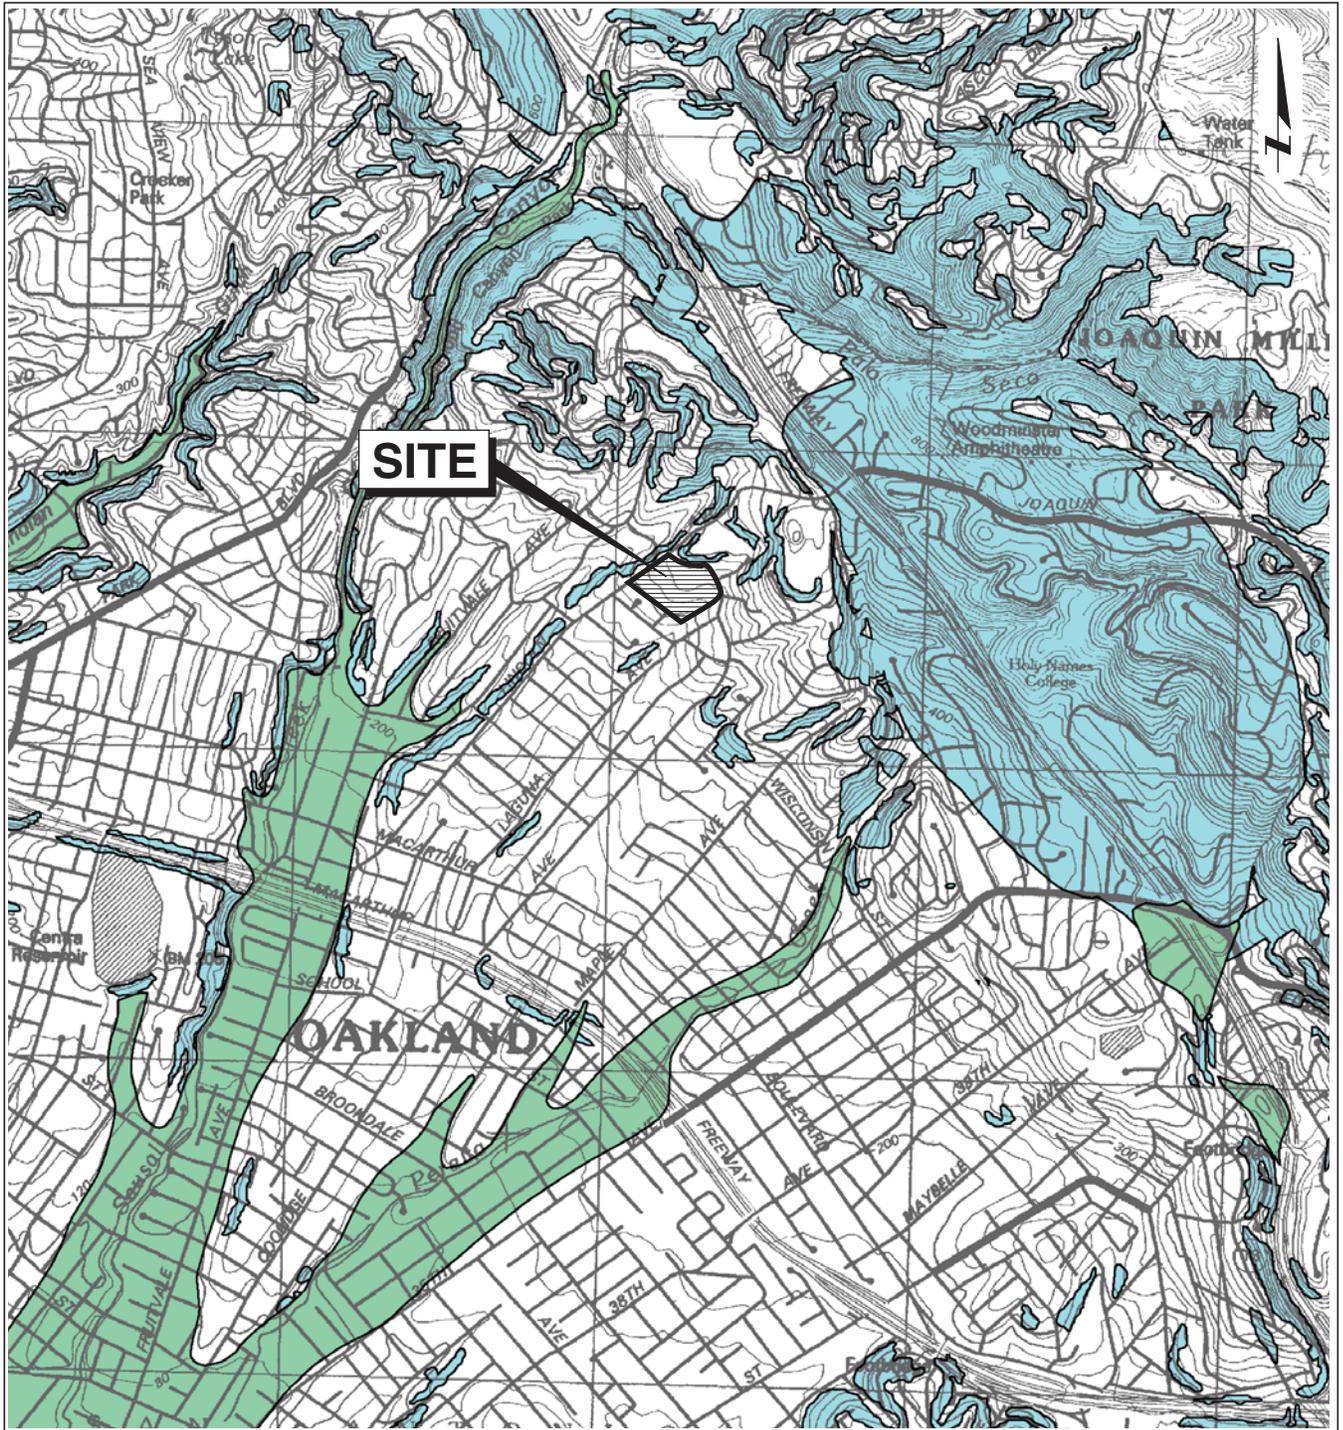
<p>Date 04/18/12</p>	<p>Project No. 12-412</p>	<p>Figure 4</p>

**EXPLANATION**

- Liquefaction;** Areas where historic occurrence of liquefaction, or local topographic, geological, geotechnical, and subsurface water conditions indicate a potential for permanent ground displacements.
- Earthquake-Induced Landslides;** Areas where previous occurrence of landslide movement, or local topographic, geological, geotechnical, and subsurface water conditions indicate a potential for permanent ground displacements.

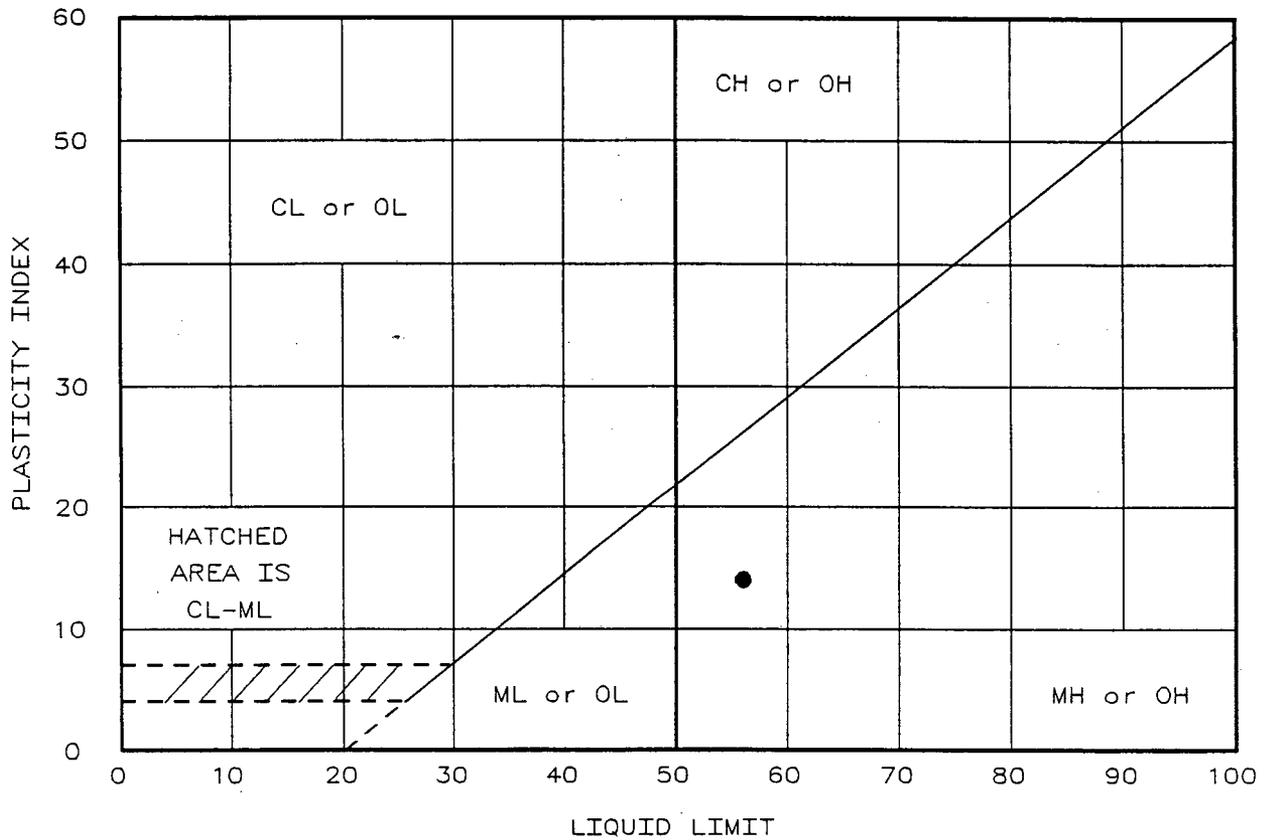
# LIQUID AND PLASTIC LIMITS TEST REPORT

Location + Description	LL	PL	PI	-200	ASTM D 2487-90
● LINCOLN CHILD CENTER	56	42	14

Project No.: G13134  
 Project: LINCOLN CHILD CENTER  
 Client: LINCOLN CHILD CENTER  
 Location:  
 Date: 9-22-98

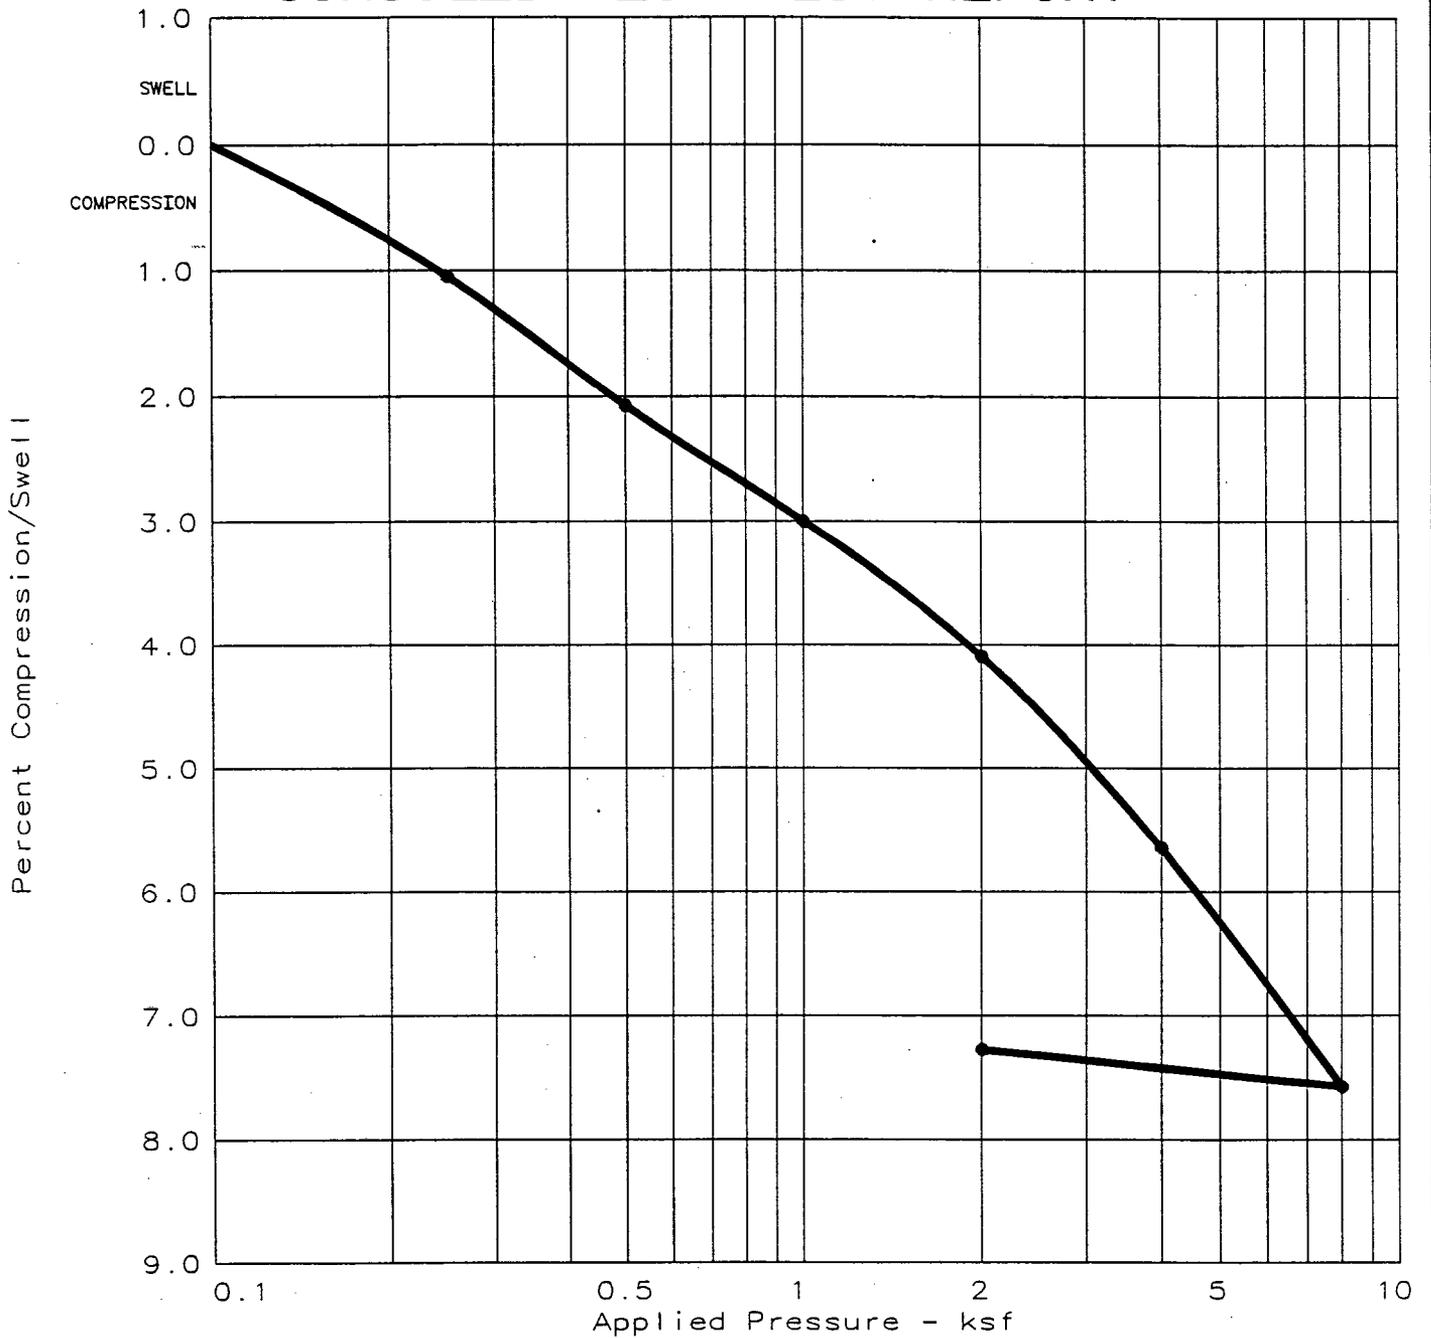
# CONSOLIDATION TEST REPORT

Natural Saturation	Natural Moisture	Dry Dens. (pcf)	LL	PI	Sp.Gr.	Initial void ratio
72.9 %	18.9 %	109.1			2.650	0.6878

TEST RESULTS	MATERIAL DESCRIPTION
	BRN LEAN CLAY W/GRAVEL
Project No.: G13134 Project: LINCOLN CHILD CARE Location: BORING 1, DEPTH 6-6.5  Date: 9-21-98	Remarks: SAMPLE BORING 1, AT A DEPTH OF 5 FEET, FILL
CONSOLIDATION TEST REPORT  <b>Consolidated Engineering Laboratories</b>	Fig. No. B5

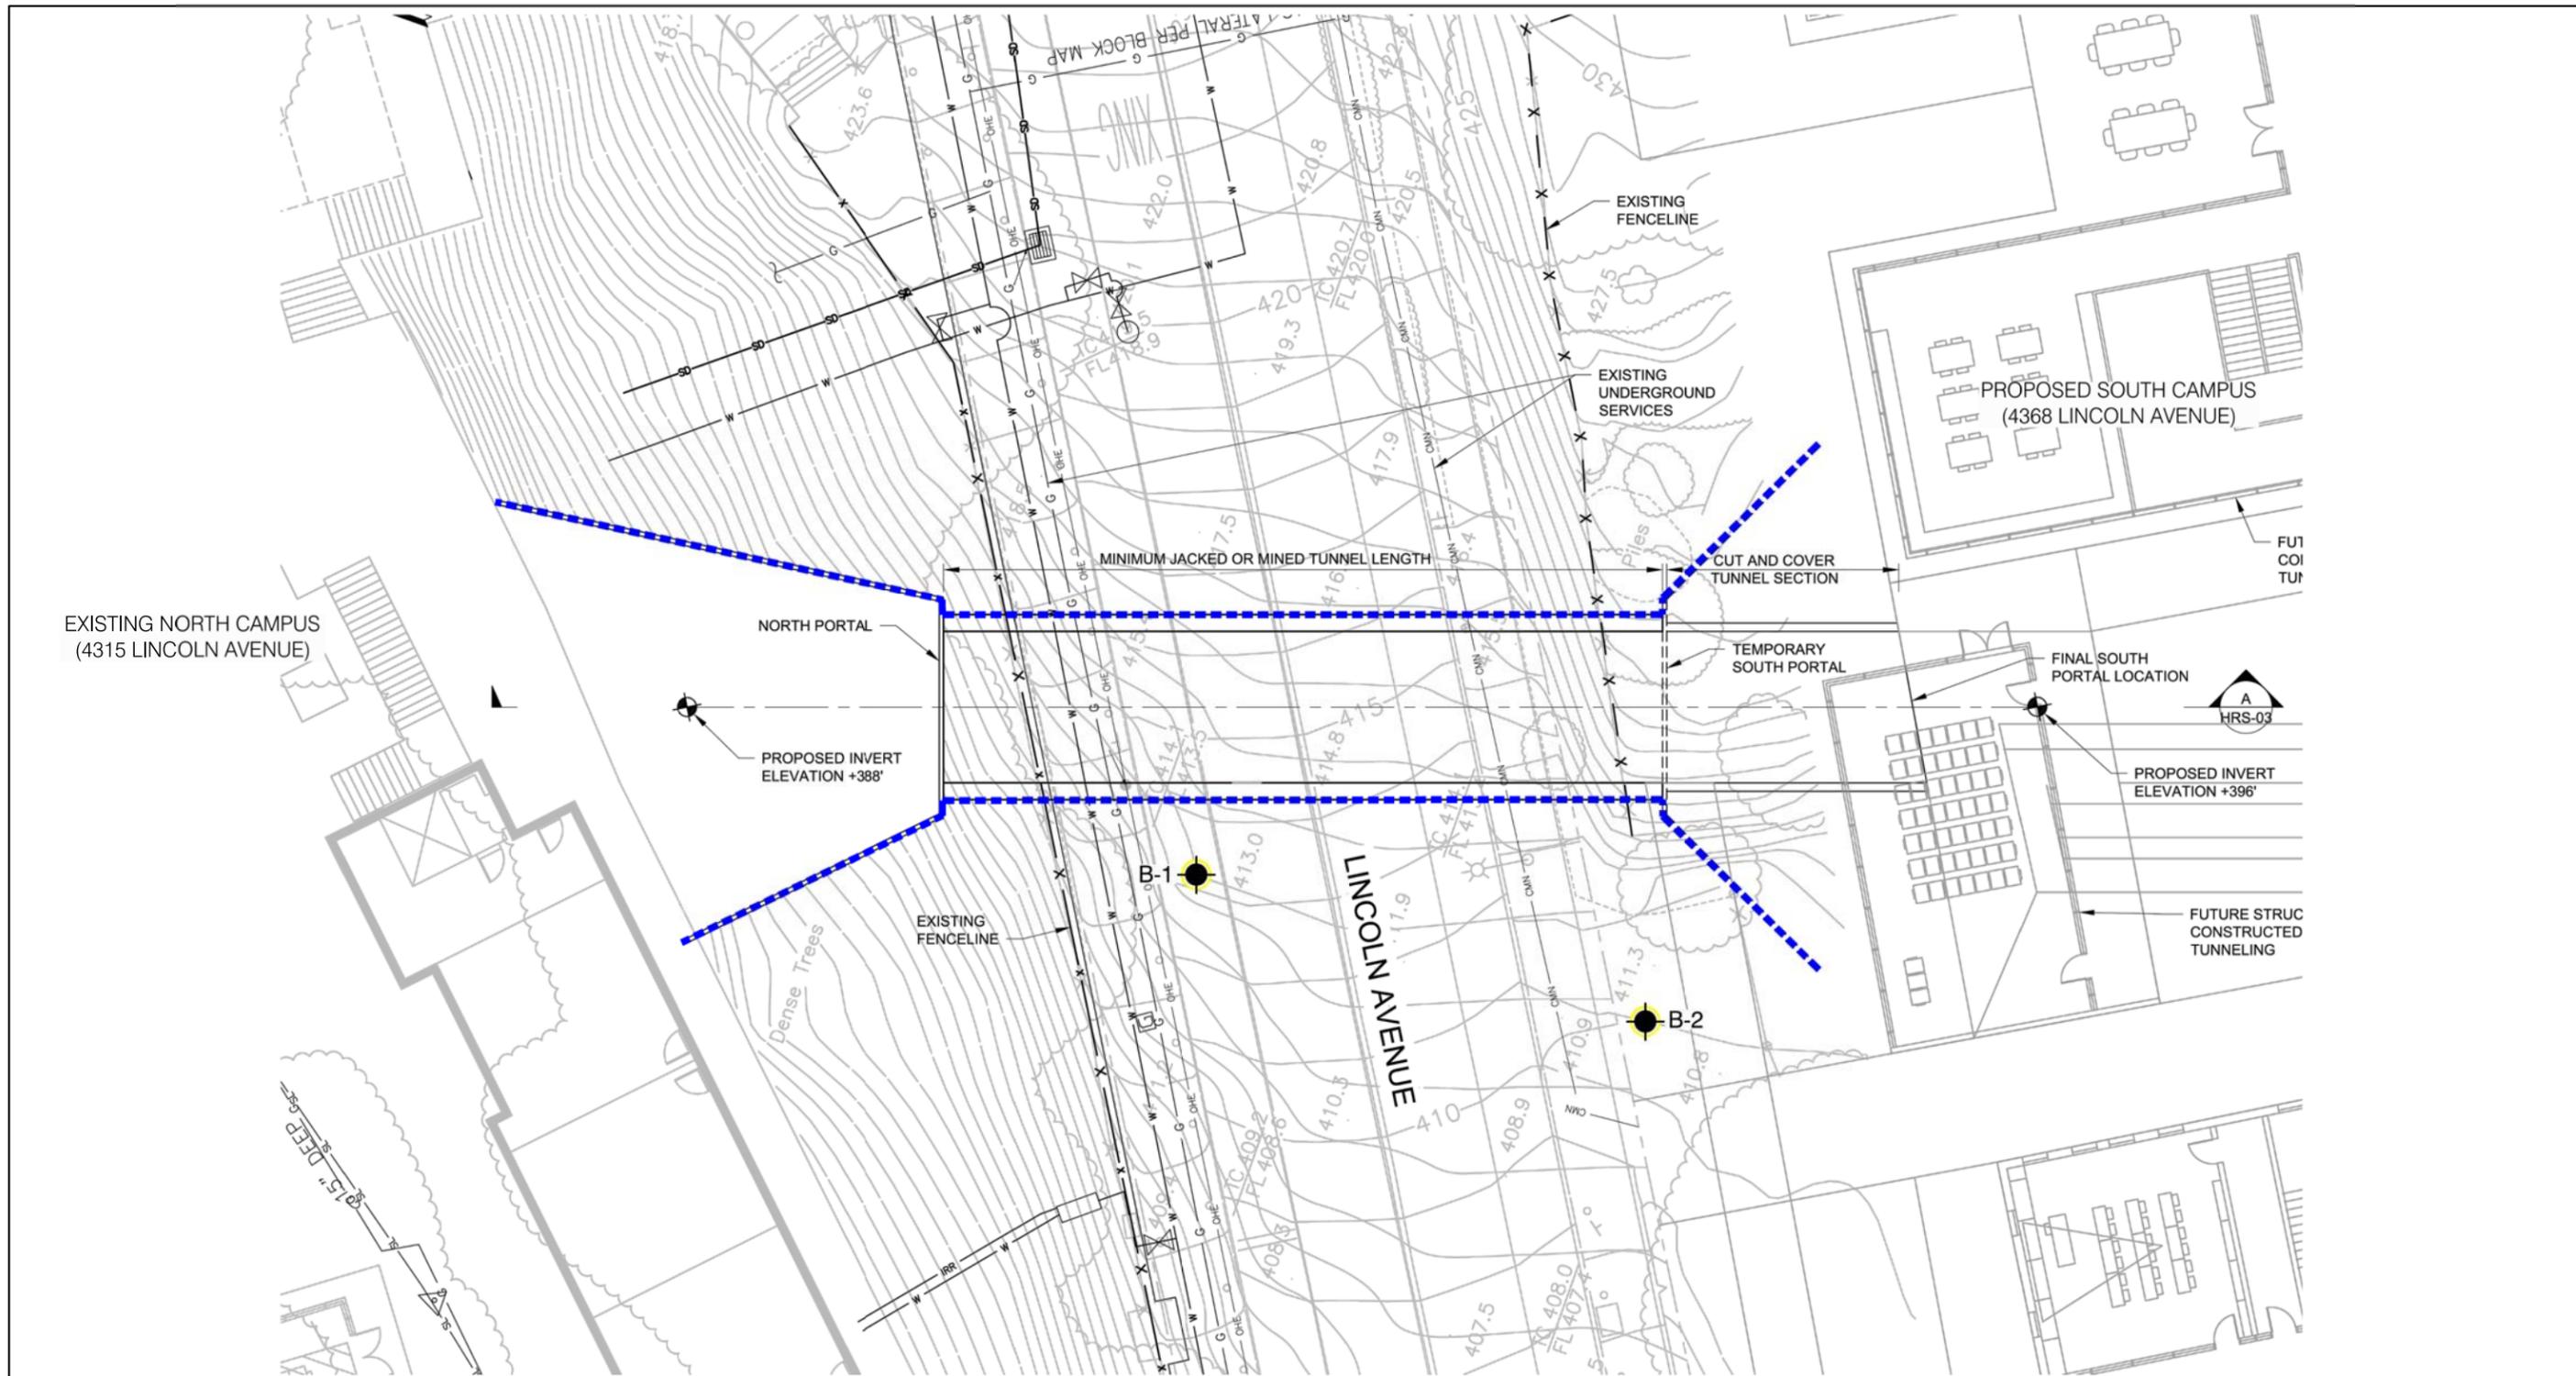
Figure 1

- B-1 Approximate location of boring/rock core by Rockridge Geotechnical Inc., March 25, 2017
- Approximate alignment of proposed tunnel and portal structures, based on preliminary conceptual design (subject to change during final design and procurement).

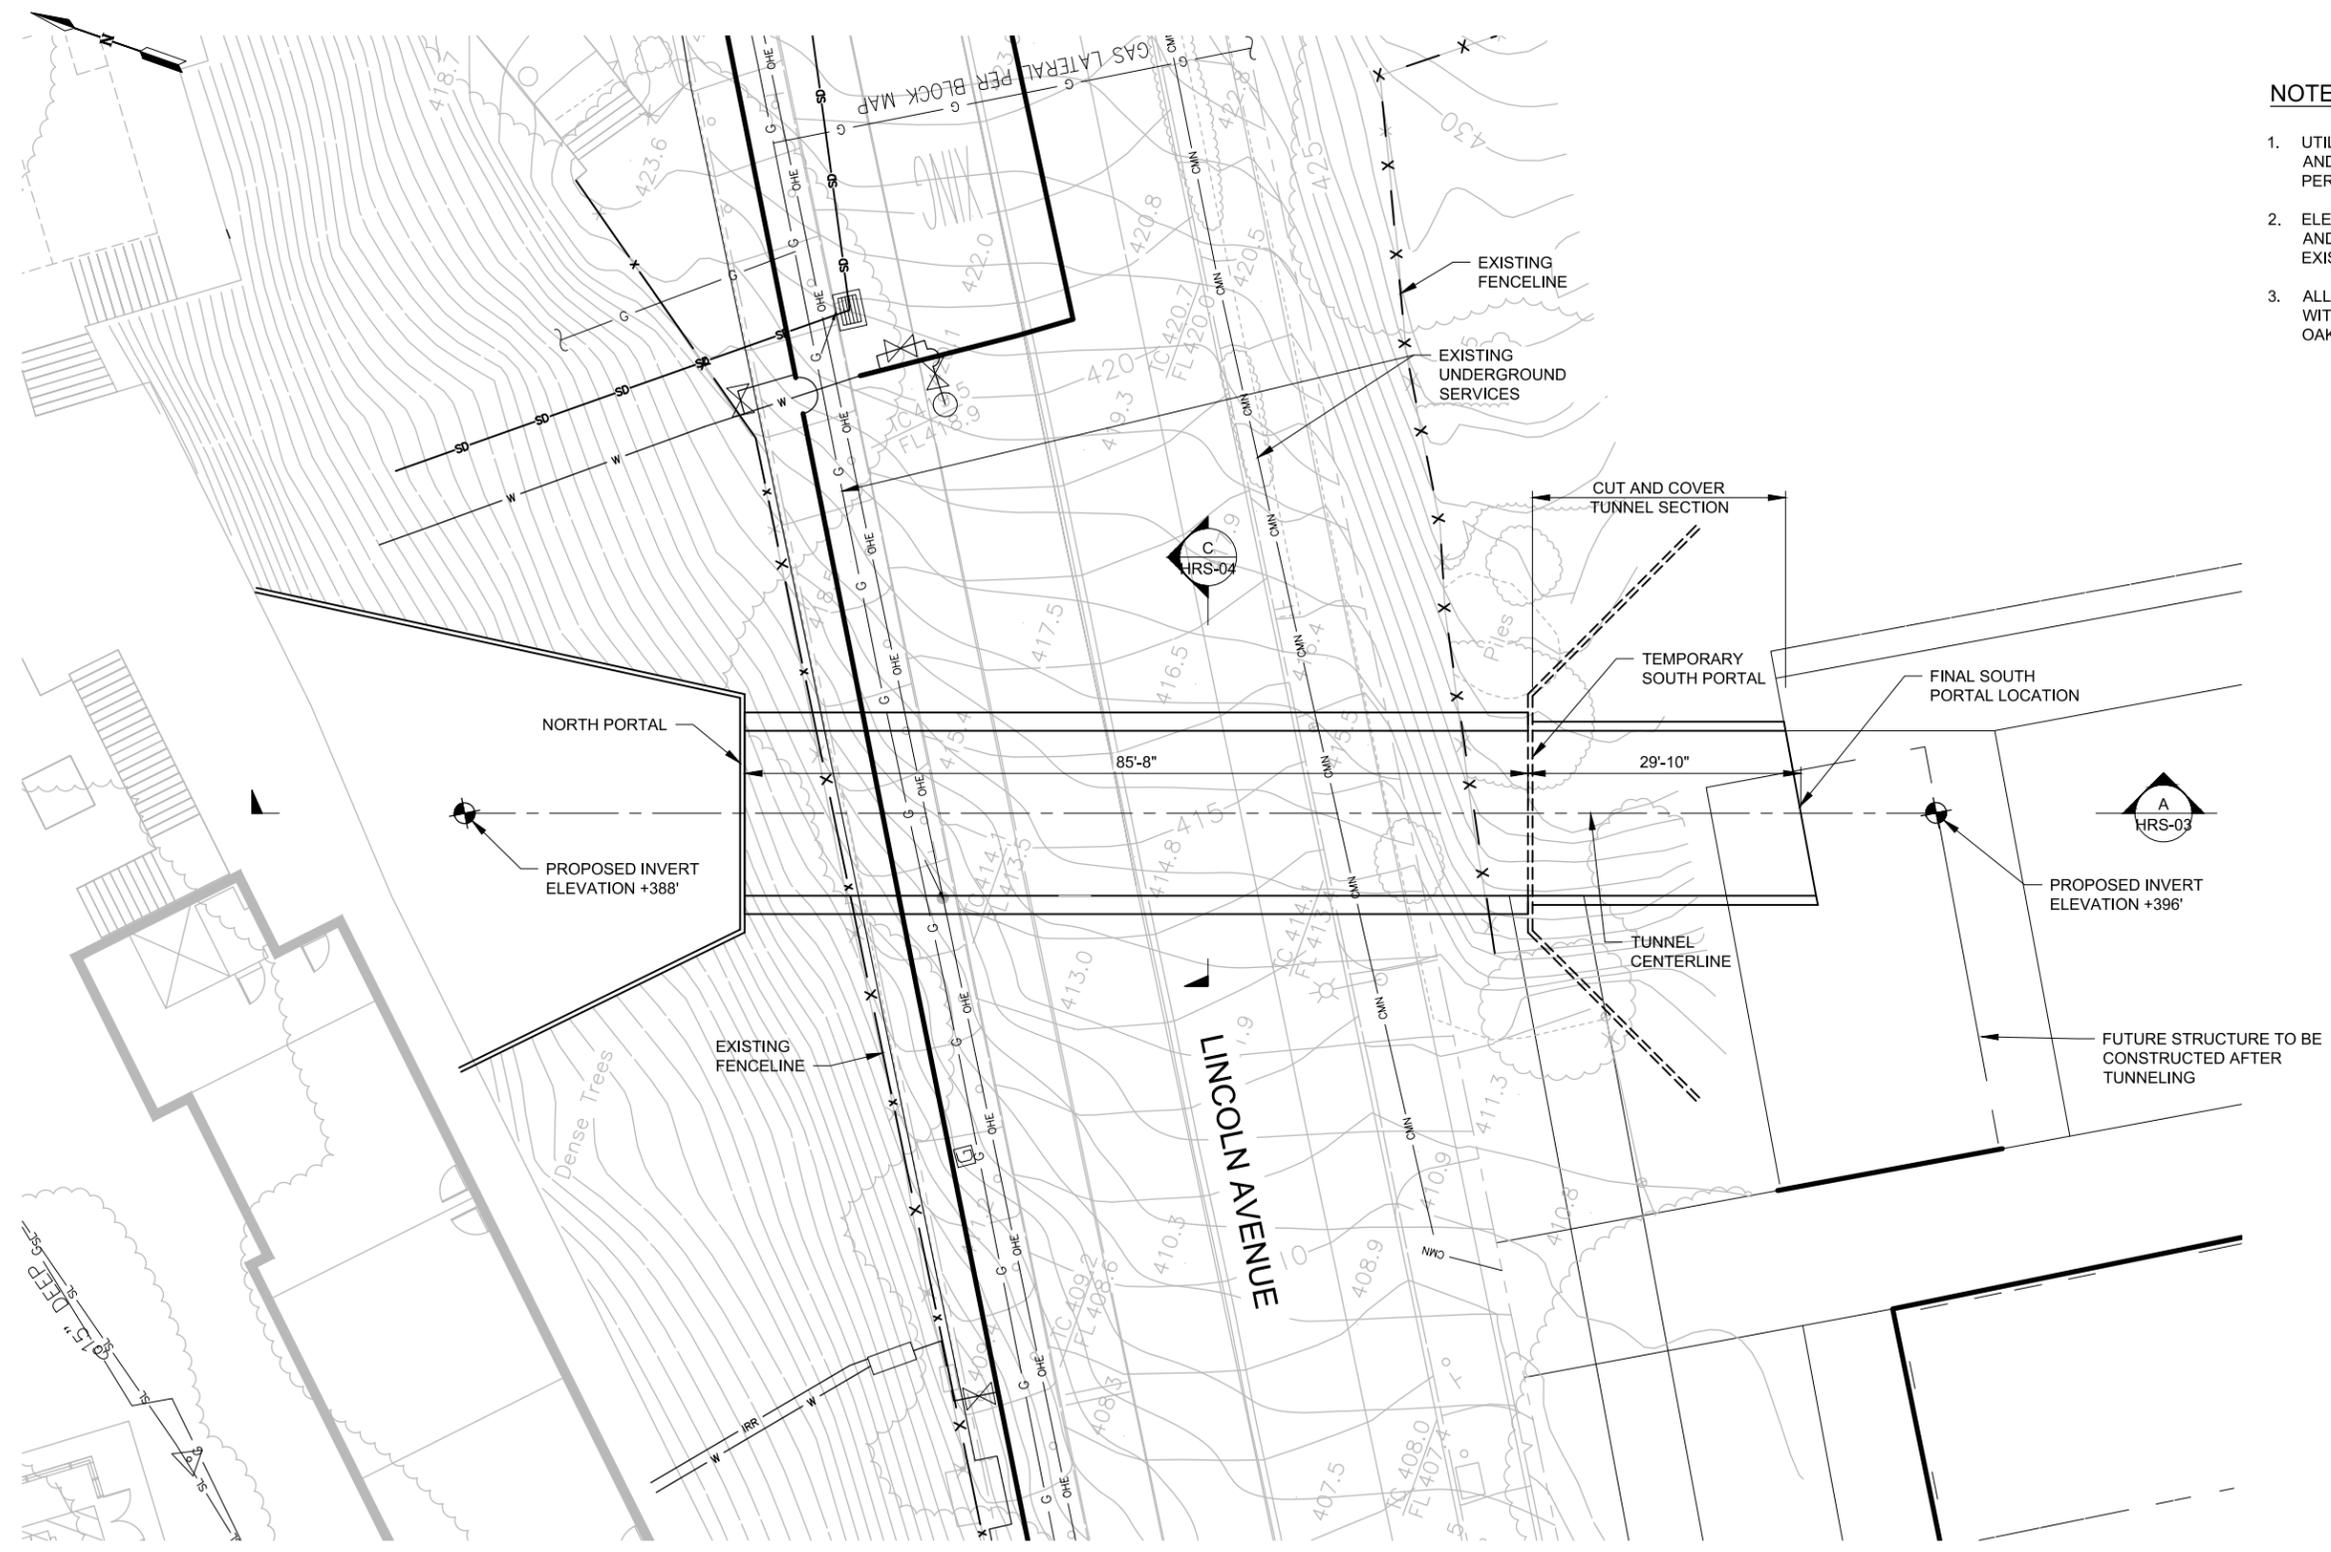
**TUNNEL PLAN**

- NOTES:**
1. UTILITY LOCATIONS ARE INDICATIVE ONLY. AS-BUILT LOCATIONS AND DEPTHS OF ALL UTILITIES SHOULD BE VERIFIED PRIOR TO PERFORMING EXCAVATION.
  2. ELEVATION CONTOURS SHOWN REPRESENT EXISTING GRADE AND NOT THE FINAL GRADING PLAN. ELEVATIONS SHOWN ARE EXISTING ELEVATIONS UNLESS OTHERWISE NOTED.
  3. ALL TEMPORARY OR PERMANENT STRUCTURE ENCROACHMENT WITHIN THE LINCOLN AVE R.O.W. IS SUBJECT TO CITY OF OAKLAND PERMITTING.

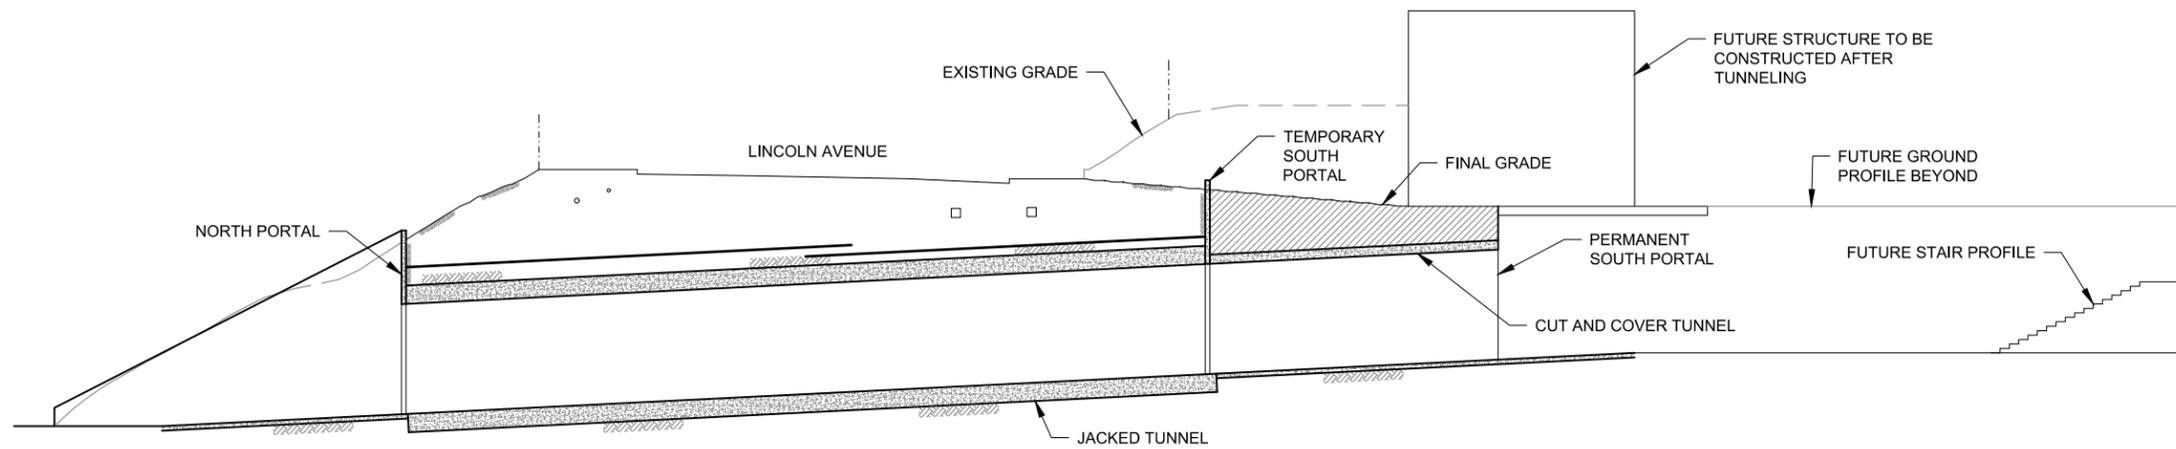
**SECTION A**  
SCALE: 1" = 10' HRS-02

1. SECTION SHOWN THROUGH CENTERLINE OF TUNNEL ALIGNMENT AND DOES NOT REPRESENT MINIMUM COVER CONDITION.
2. GROUND IMPROVEMENT ZONES AND FACE SUPPORT NOT SHOWN FOR CLARITY.

NOTE: CONSTRUCTION SEQUENCE FOR JACKED OPTION SHOWN ON DRAWING HRS-06

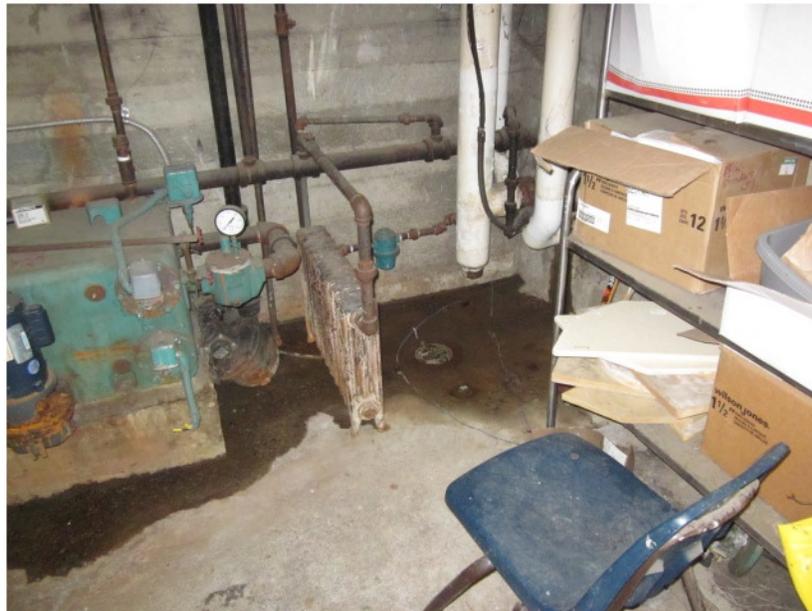
Photo 2.  
Water leakage in basement of Building 1.

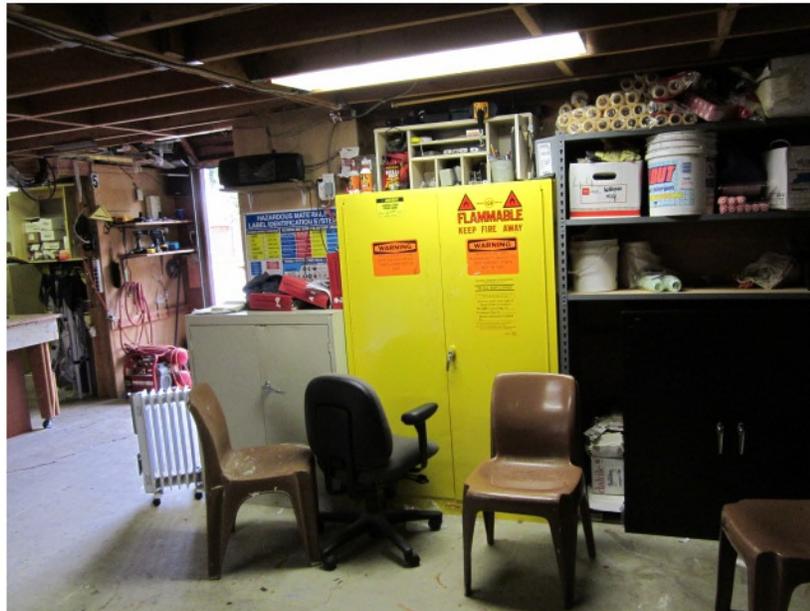
Photo 2.  
Hazardous material storage in Building 5.

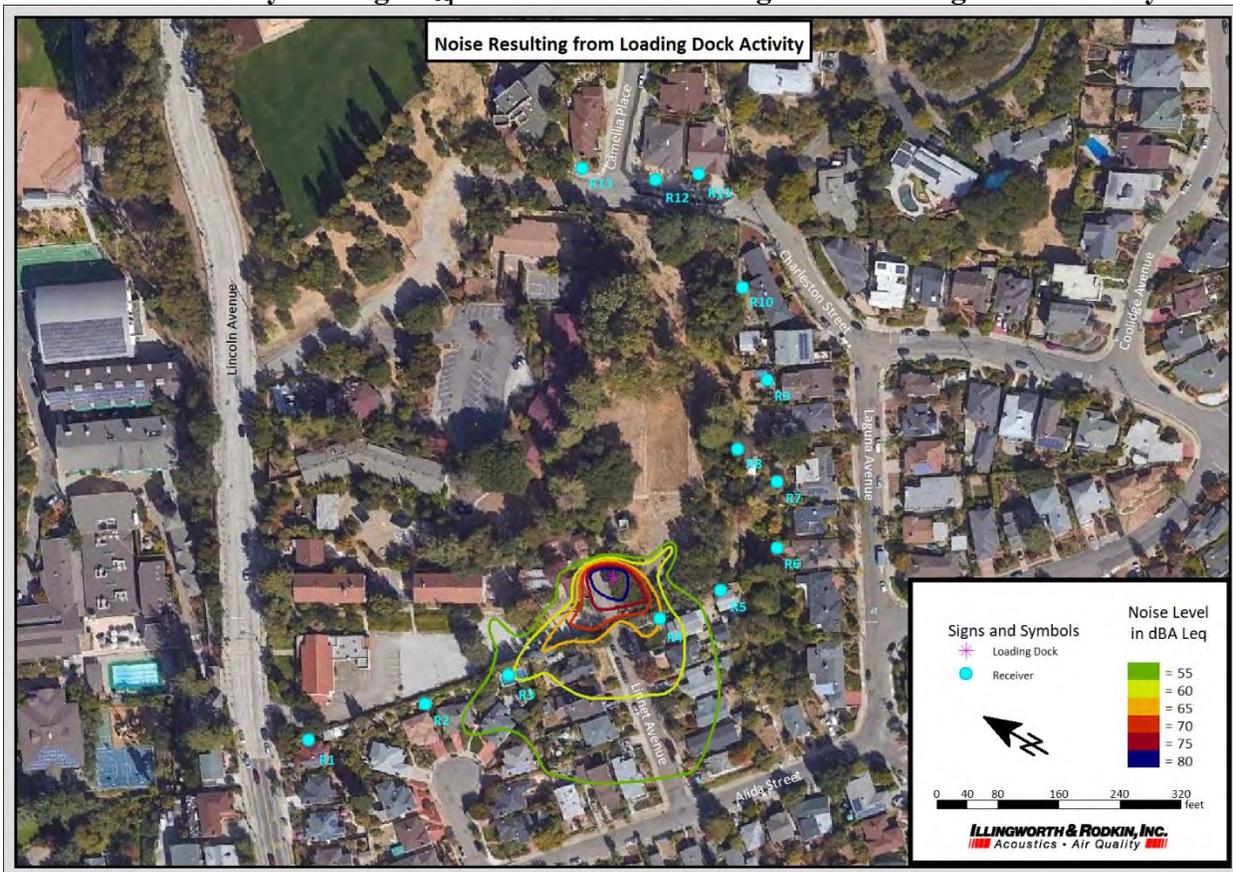
**FIGURE 11: Hourly Average L<sub>eq</sub> Noise Contours during PAC Loading Dock Activity**

Noise levels generated during loading dock activities at the PAC would be anticipated to exceed the daytime thresholds established by the City of Oakland at some nearby residences to the south. Noise reducing strategies are provided to reduce annoyance to residents (see Mitigation Measure 1b). This is a **potentially significant** impact.

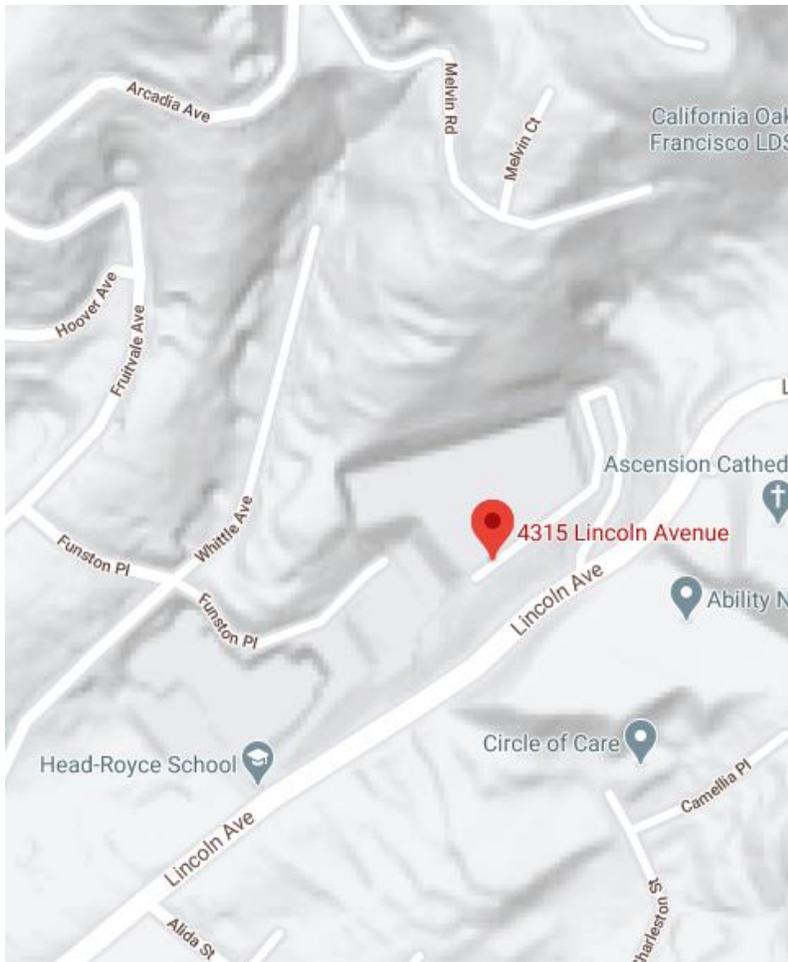
The site of the north campus itself is fairly flat, and the playing fields, pool and tennis courts completely so. Many of the instructional buildings and the Gymnasium are at the base of the bowl, while the administrative buildings sit higher on the site, at Lincoln Ave. The south campus site is generally flat; the topography poses no particular hazard.

*Figure 5 Terrain in immediate vicinity of Head-Royce School*

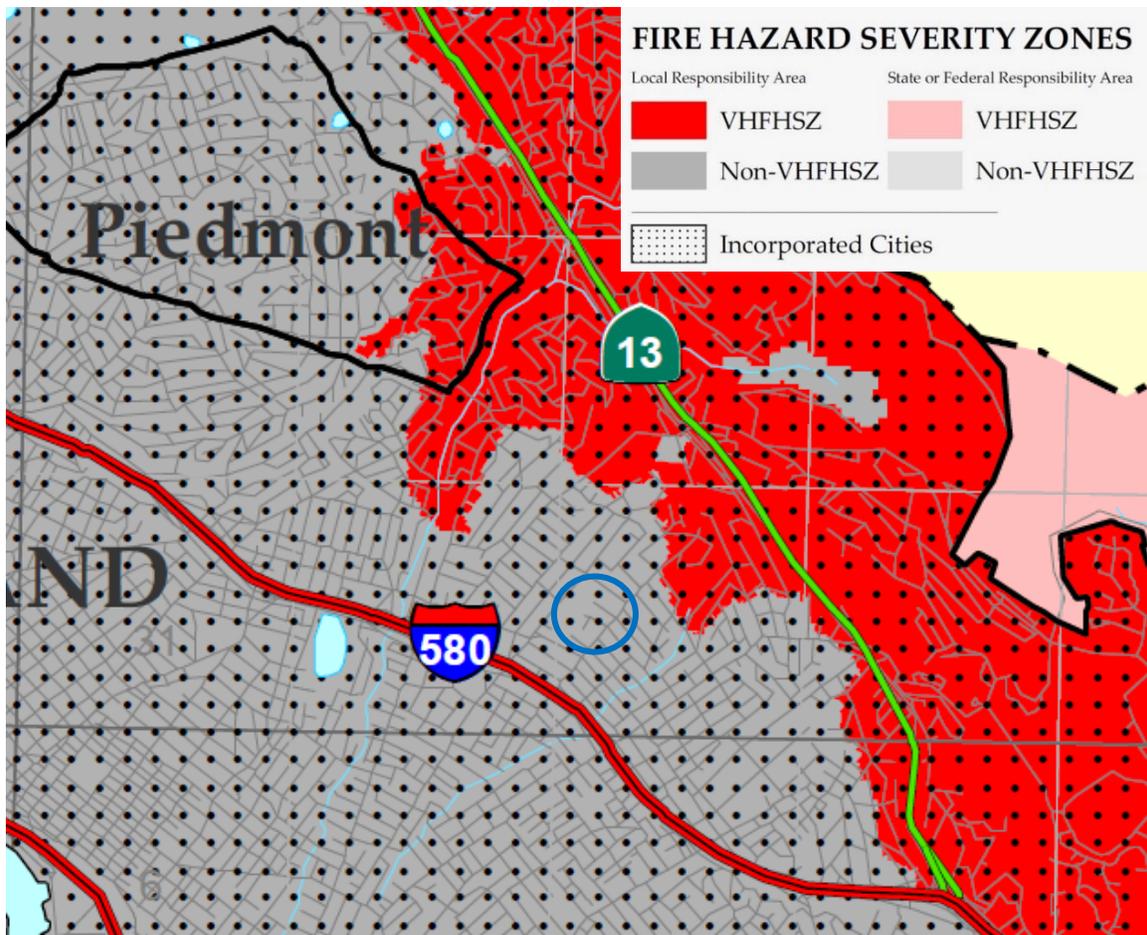
The property is located within a Very High Fire Hazard Severity Zone as mapped by CAL FIRE and as adopted by the Oakland Fire Department.

*Figure 4. Map of Fire Hazard Zones as mapped by CAL FIRE and adopted by Oakland Fire Department. Red = Very High Fire Hazard Severity Zone.*

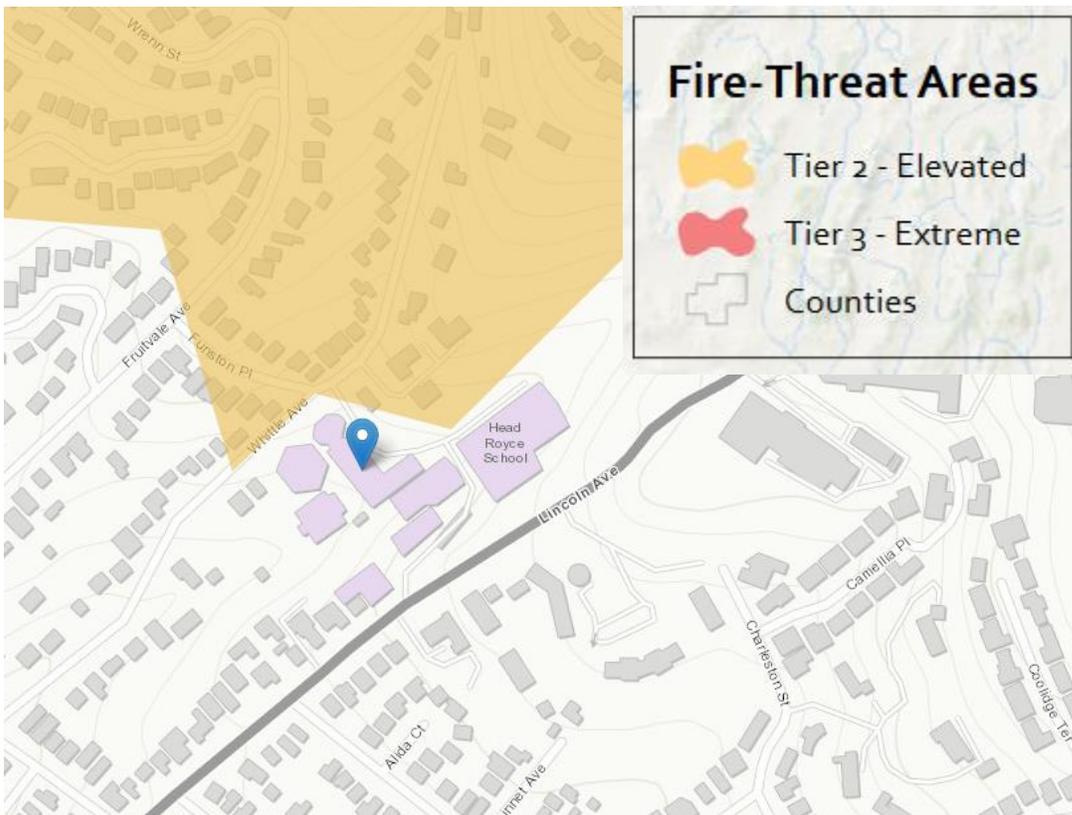
Figure 5. Map of California Public Utilities Commission (CPUC) Fire Threat Map (2018). The CPUC Fire-Threat Map depicts areas where enhanced fire safety regulations found will apply.
