CITY OF OAKLAND DRAINAGE STUDY

EMPIRE ROAD AND BERNHARDT DRIVE DRAINAGE AREAS

Prepared for the City of Oakland

June 2022

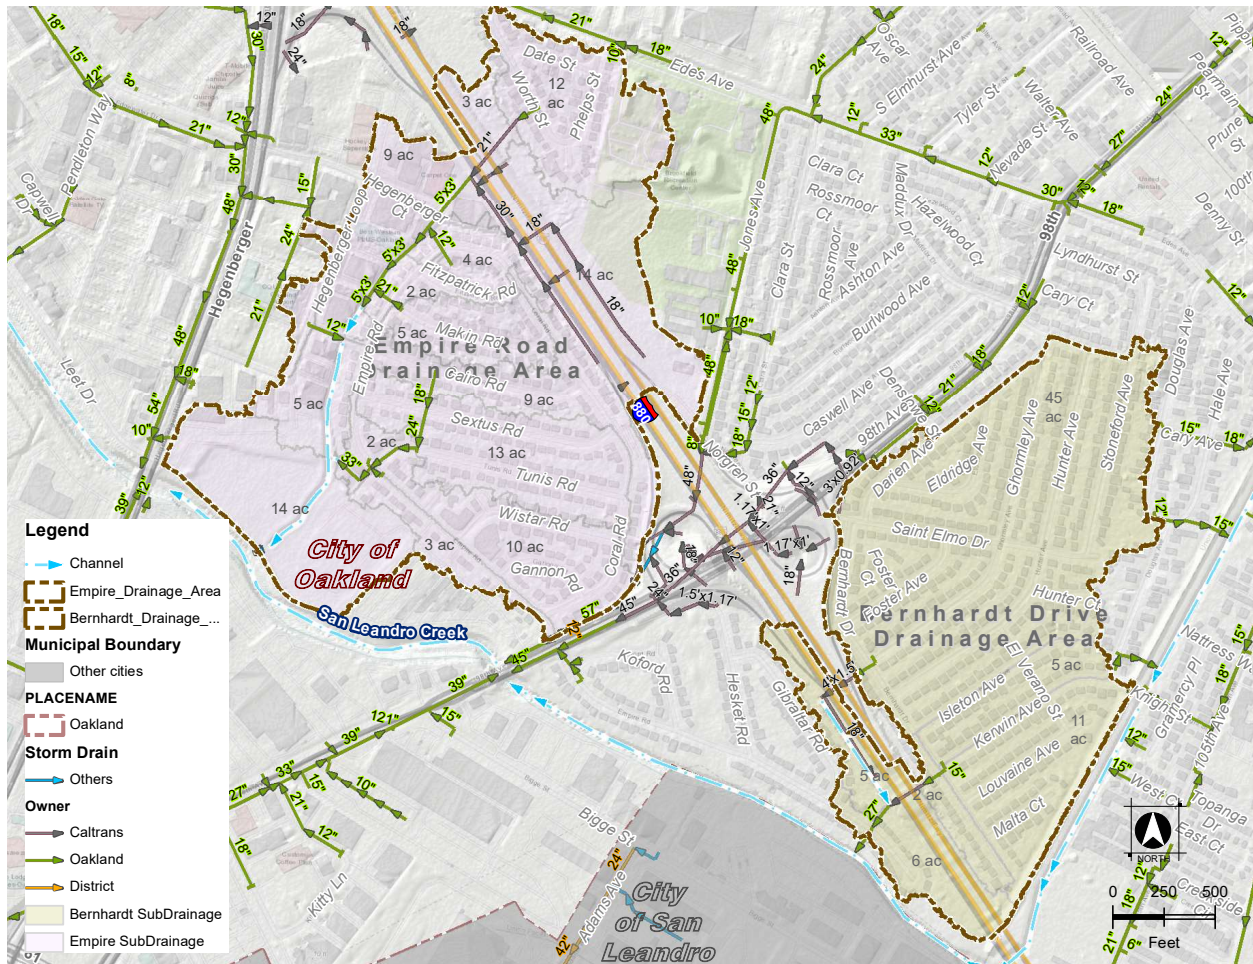
Both the Empire Road and Bernhardt Drive drainage areas and their respective drainage systems are shown in **Figure 3**.

The Empire Road drainage area is located in the Columbia Gardens neighborhood (Figure 3). The drainage area is bound by Edes Avenue to the north, 98th Avenue to the east, Hegenberger Road to the west, and San Leandro Creek to the south. The drainage system within the drainage area consists of approximately 5,600 feet of storm drain pipes varying from 12 to 48 inches in diameter and a few box culverts, and 1,300 feet of engineered earthen channels. The pipes and channels collect stormwater runoff from 105 acres of low-lying residential neighborhoods, a school, I-880 rights-of-way, and open space areas before discharging the runoff to San Leandro Creek through twin 48-inch culverts with flap gates. The flap gates prevent high water levels in San Leandro Creek from flowing backward and upstream along the drainage system. The high water levels in San Leandro Creek oftentimes prevent stormwater in the drainage system from discharging effectively.

The Bernhardt Drive drainage system is located in the Brookfield Village neighborhood. The drainage area is bound by Edes Avenue to the north, Stonehurst Creek to the east, 98th Avenue to the west, and San Leandro Creek to the south. The drainage system within the drainage area consists of approximately 1,600 feet of storm drain pipes varying from 12 to 33 inches in diameter and a few box culverts, and 600 feet of heavily vegetated ditch. The pipes and ditch collect stormwater runoff from 74 acres of residential neighborhoods and I-880 rights-of-way before discharging the runoff to San Leandro Creek.

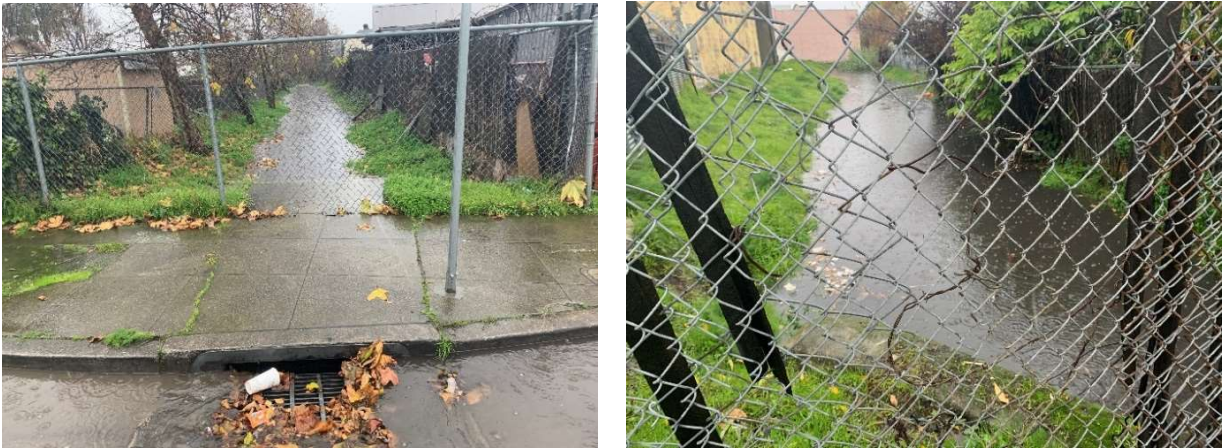
Figure 5 – Observed Flooding at Cairo Road Crossing on January 16th, 2020

Figure 5 shows the overflowing channel at the Cairo Road crossing on the channel along the Empire Road drainage system during the January 16, 2020 storm event. The storm had 0.23 inches of rainfall within the peak 15 minutes based on data from the Alameda County gauge at the Oakland fire station on 66th Avenue, which was categorized as a 2-year storm. The flooding caused by this storm event indicates severe capacity deficiencies of this system.

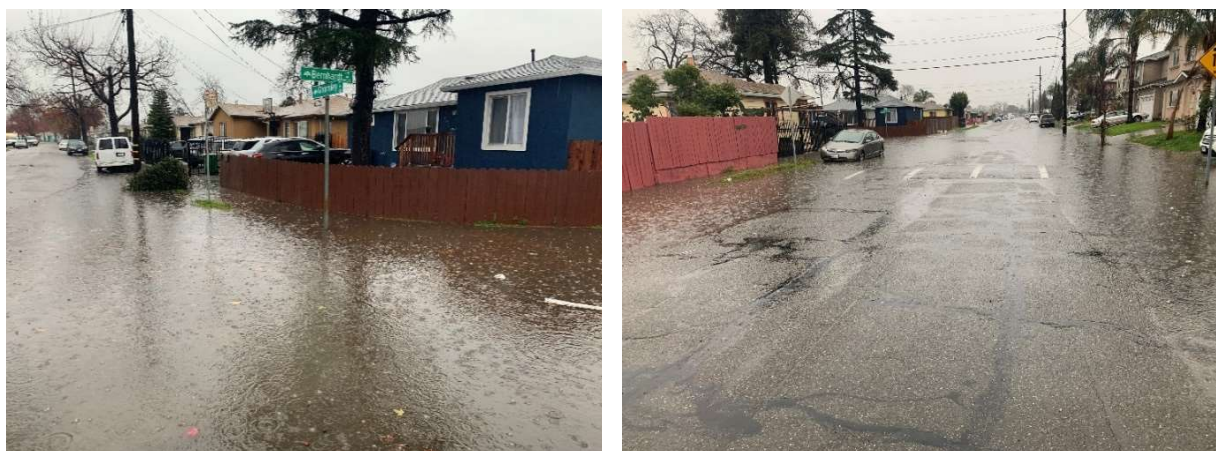
Figure 6 – Observed Flooding at Bernhardt Drive on January 16, 2020

Figure 6 shows the overflowing Empire Road storm drain system along Bernhardt Drive during the January 16, 2020 storm event. The catch basins were reported as overflowing, and the streets and properties were flooded. The flooding caused by this storm event indicates severe capacity deficiencies of this system.

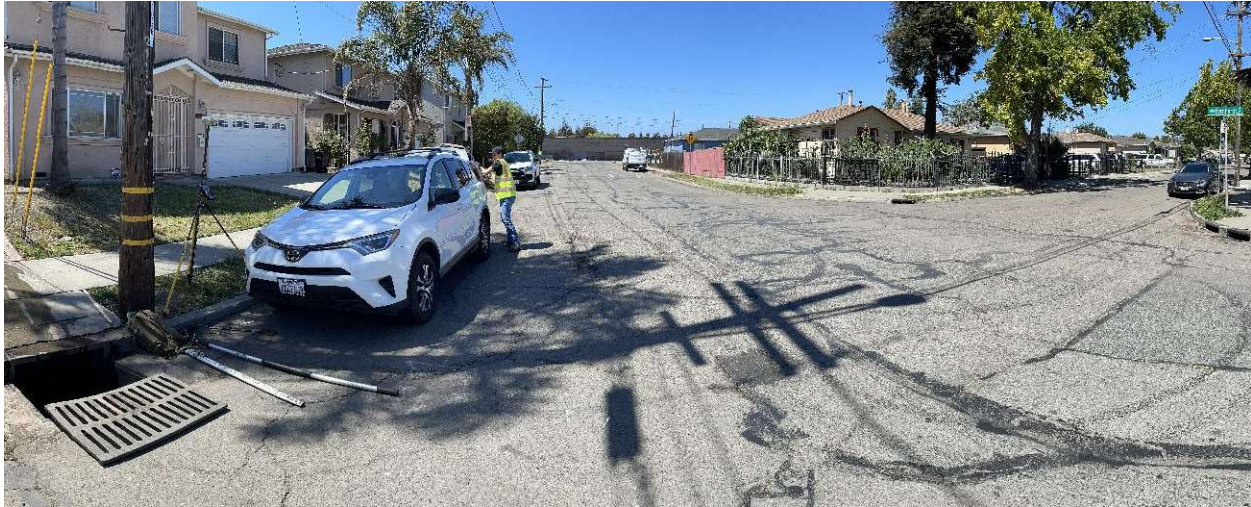
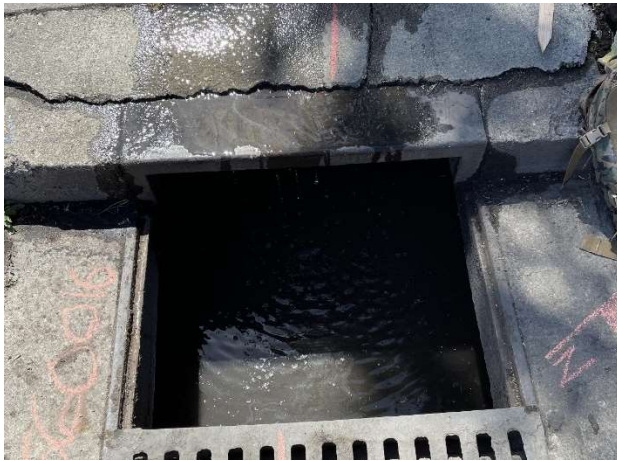
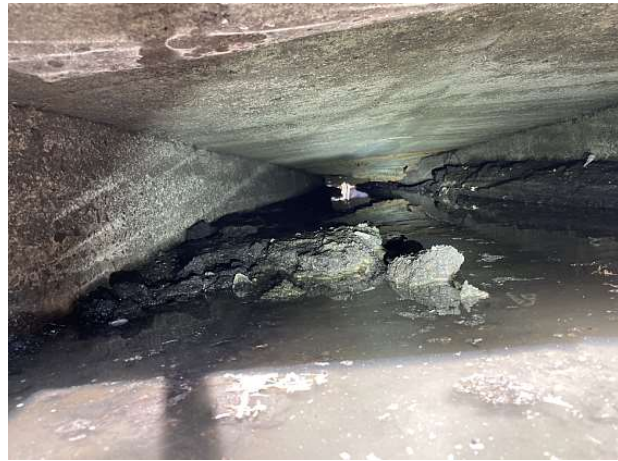
Figure 8 – Catch Basin on Bernhardt Drive (top); Standing Water in Catch Basin (lower left);
Sedimented Culvert (lower right)

Standing water was observed during a dry, sunny day inspection in the catch basin on Bernhardt Drive, as shown in **Figure 8**. Excessive sedimentation built up in the absence of sufficient maintenance, which has led to standing water and recurring and excessive flooding in the storm events as discussed in **Section 2.3**.

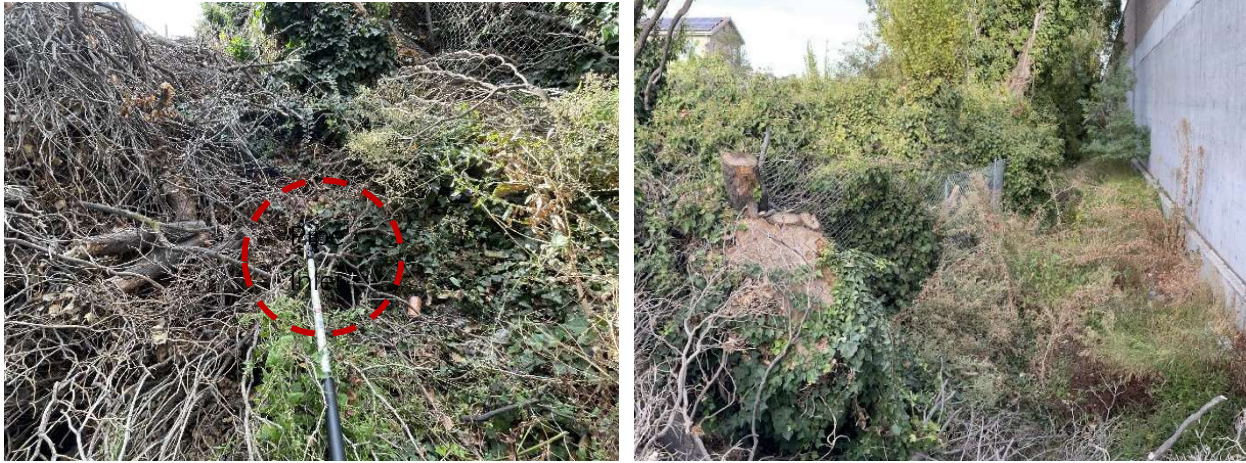
Figure 9 – Overgrown Pipe Inlet (left); Overgrown Channel (right)

The other maintenance deficiency within the study area is caused by excessive vegetation growth. Vegetation clearing has not been performed maintain the capacity of the open drainage channels as shown in **Figure 9**. The deficiency of the channel west of I-880 at the Bernhardt Drive sub-drainage area is further complicated by access to the channel because the City does not own the property or an easement.

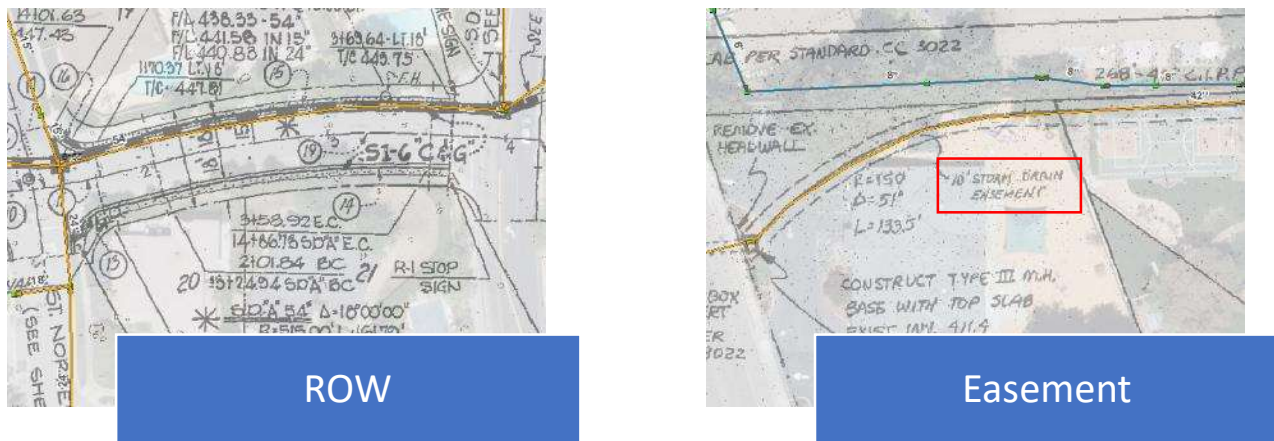
Figure 15 – Ownership Categorization

Figure 15 shows the georeferenced as-built, aerial image, and storm drain pipes (orange lines) that were constructed within the public ROW along streets. These pipes were categorized as City-owned. The right-side image in **Figure 15** shows the georeferenced as-built, aerial image, and storm drain pipes (orange lines) that were crossing private properties where easements were dedicated to the City. These pipes were categorized as City-owned on dedicated easements.

Facilities outside the ROW or easements were identified in this section using the georeferenced as-builts as shown in **Figure 15**.

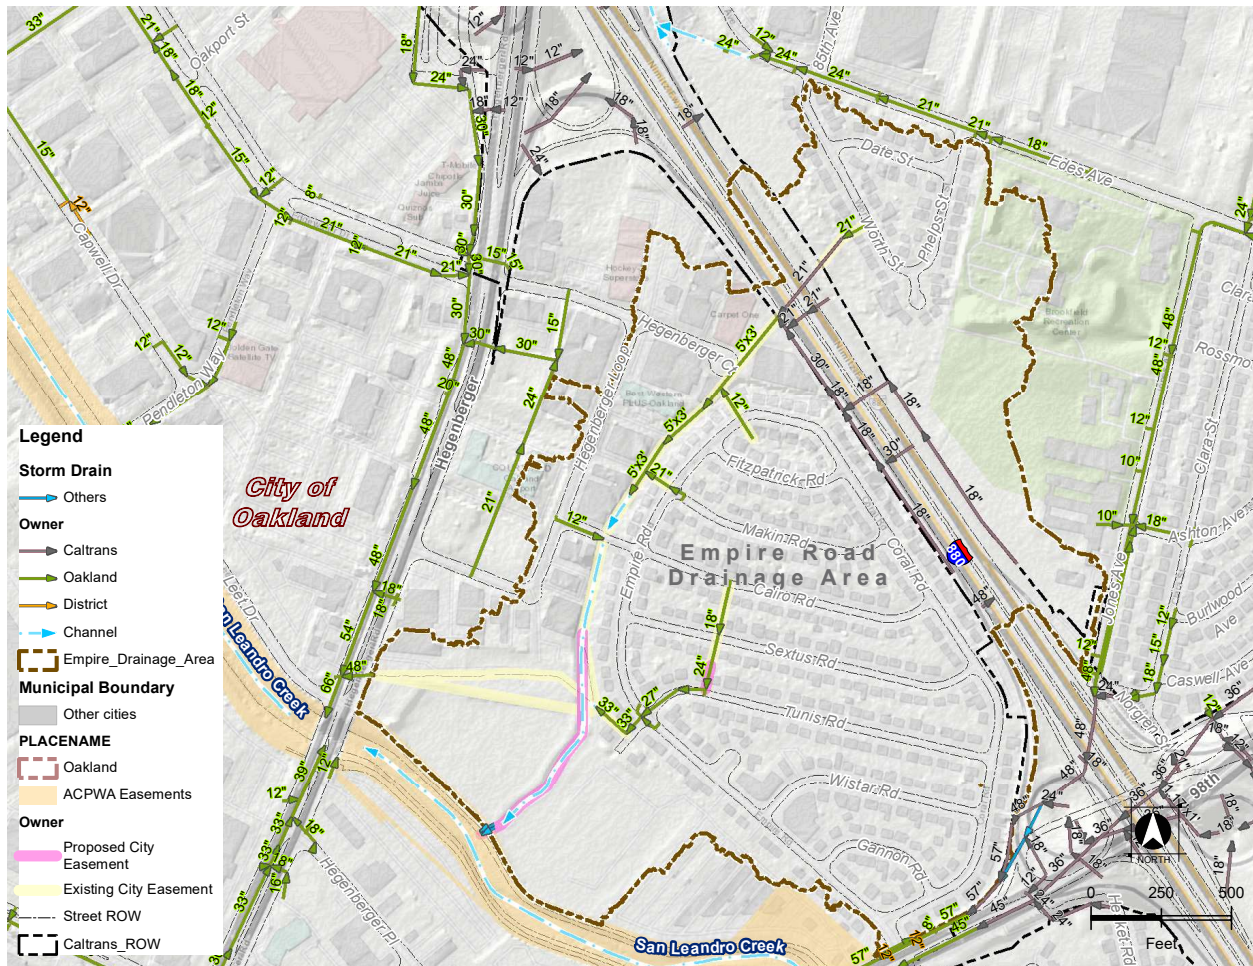
Figure 16 – Empire Road Drainage System Ownership Based on ROW and Easements

Based on the City Sewer Maps, the City owns the storm drain pipes within the Empire Road Sub Drainage Area on public ROW or dedicated easements. There is an approximately 30-foot-wide easement provided along the earthen open channel from Makin Road to Tunis Road that then turns west and connects to a 48-inch RCP that eventually discharges into San Leandro Creek. In 2008 (based on *Google Earth* historical images and recent LiDAR), the property owner abandoned the drainage facilities connecting the open channel to the 48-inch RCP to the west at Hegenberger Road and constructed a 100-foot-wide open channel (see the pink alignment in **Figure 16**) that drains south to San Leandro Creek. Two 48-inch culverts with flap gates were also constructed at the downstream end of the constructed open channel. As shown in **Figure 16**, a 900-foot-long and 120-foot-wide easement (including an access road) is proposed for acquisition along the open channel and dedicated to the City for proper maintenance and flood control for the upstream storm drain systems.

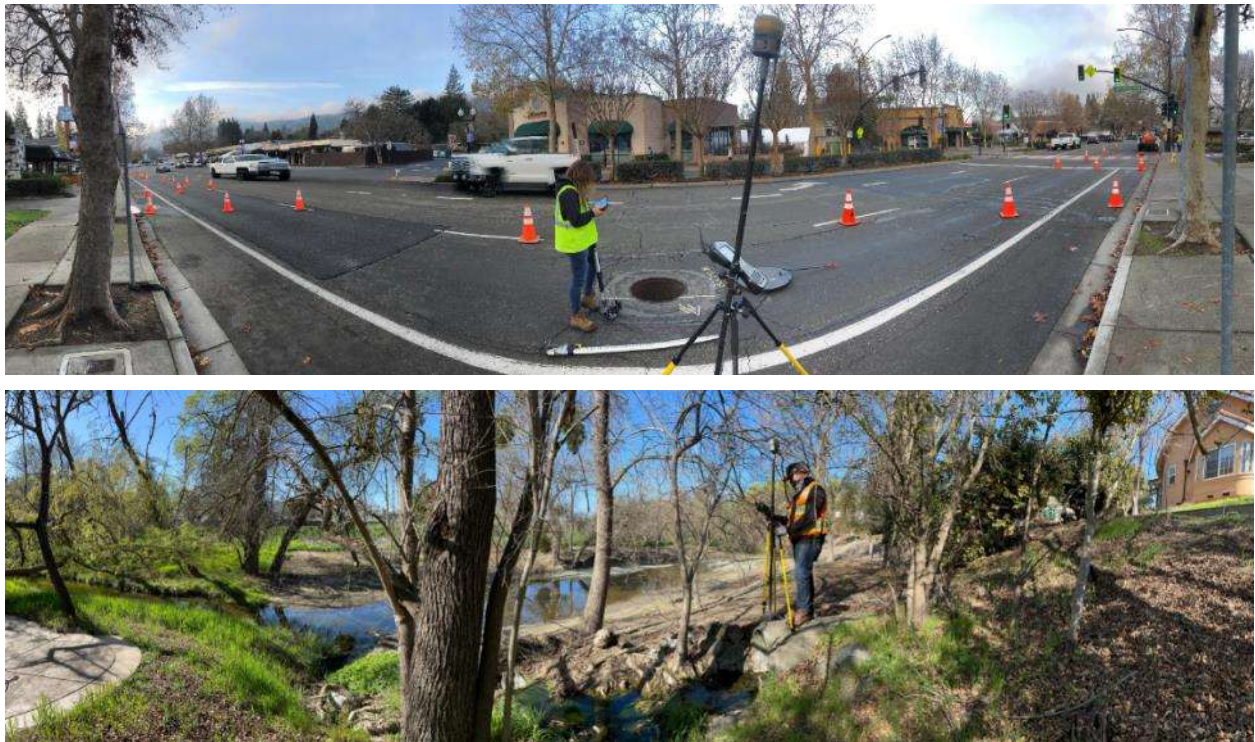
Figure 18 – Typical Pipe (above) and Outfall (below) Inspection and Survey

The field inspector or engineer utilized several standard inspection tools to document pipe/structure information (diameter, shape, material, depth, etc.), assess the pipe/structure conditions, and record any observed performance issues (plugging, erosions, overtopping, etc.). The inspection tools include electronic devices (digital tablets, GPS enabled cameras, and manhole inspection cameras), measurement devices (sediment probes and steel or vinyl tape measures), and standard access tools (manhole picks, sledgehammers, ratchet and sockets, and bolt hole alignment tools). The digital tablet is loaded with the ArcGIS *Survey123* application to aid the inspection as discussed in **Task 4.1**. The typical inspection setups for the storm drain system and outfall structure inspections are illustrated in **Figure 18** below.

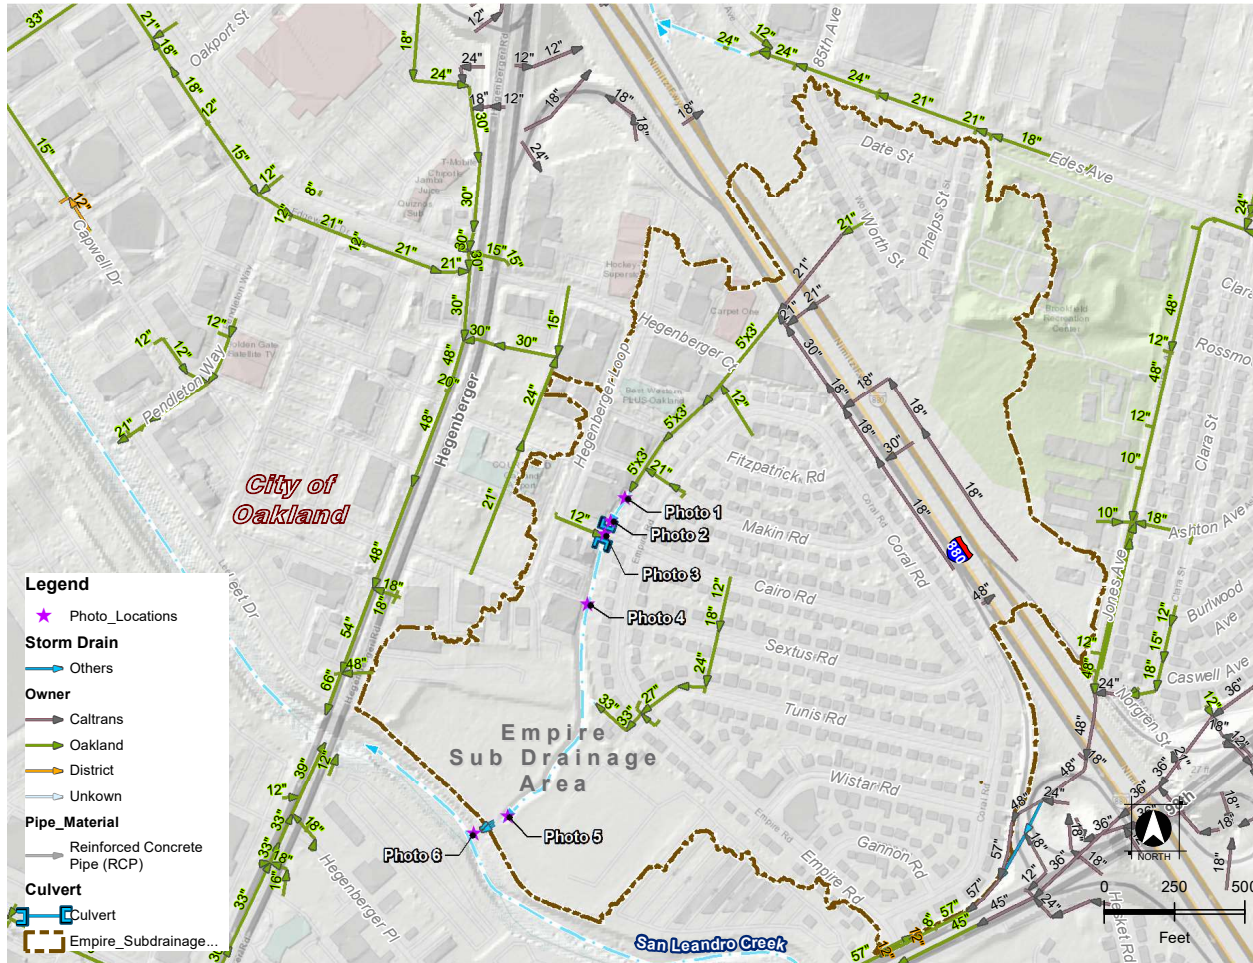
Figure 19 – Empire Road Photo Locations

The Empire Road drainage system inspection and survey focused on the open channel near the Cairo Road crossing where most of the flooding incidents were reported (see **Figure 4**) and downstream to the outfall near San Leandro Creek. The photo locations are annotated in **Figure 19**.

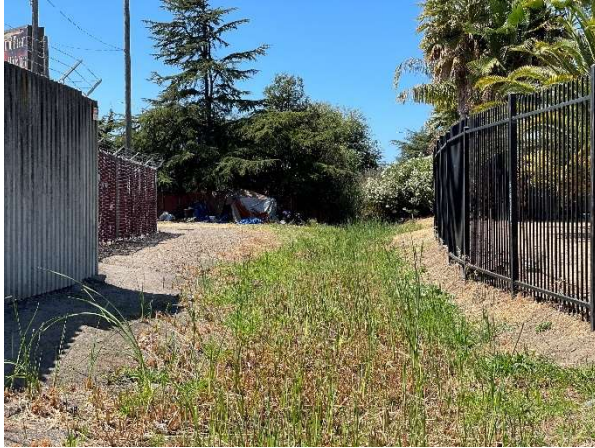
Photo 1: Channel downstream of 5'x3' RCB outfall

Based on the inspection and survey as shown in Photos 1, 2, and 4, the earthen open channel between Makin Road and Tunis Road was relatively shallow (approximately 2-4 feet deep) and narrow (approximately 20 feet wide), filled with trash, and overgrown with vegetation. The Cairo Road 6'x3' reinforced concrete box (RCB) was found 6 inches below the bounding channels, filled with standing water and 6 inches of sediment. The channel starts to widen and deepen downstream of the 33" RCP outfall where the private property owner constructed the channel in 2008 as discussed previously in **Section 4.3**. The wider channel discharges into San Leandro Creek through a twin, 48", RCP outlet structure. The inside of the north culvert was found with two 2"x10" wooden planks as shown in Photo 5.

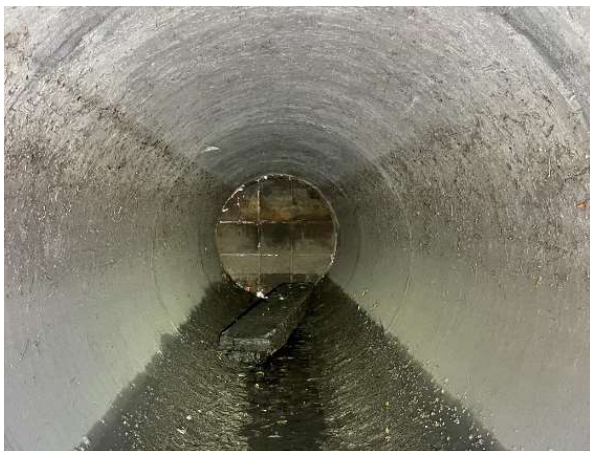
Photo 5: North 48" culvert of the outlet

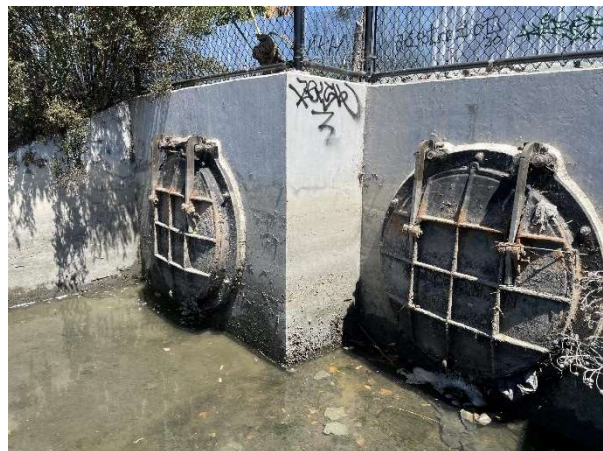
Photo 6: Flap gates on 48" culvert outlet

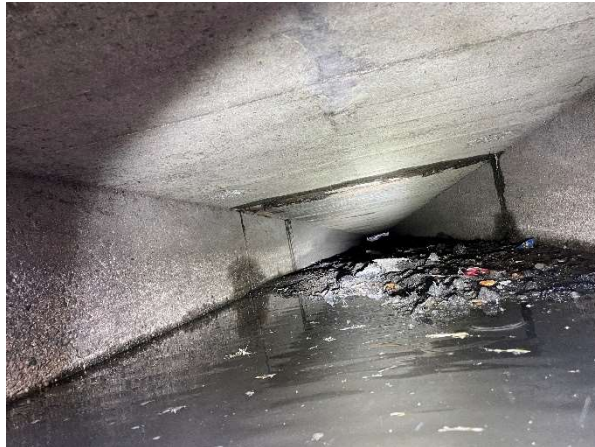
Based on the inspection and survey, the Caltrans' RCB under I-880 off Ghormley Avenue was found to have 1 inch of standing water during dry weather and 4 inches of sediment and trash (as shown in Photo 1) while the Caltrans' RCPs under I-880 off Kerwin Avenue were found to be relatively dry and clean (as shown in Photo 4). At the Photo 4 location, there are dual 15" RCPs upstream that transition to a single 18" RCP downstream, which is routed under I-880. The open channel downstream of the Caltrans' pipes is shown in Photos 2 and 3. The open channel was constructed when the freeway was widened and now resides on private properties. The open channel is difficult

Photo 1: 4'x2' RCB under I-880

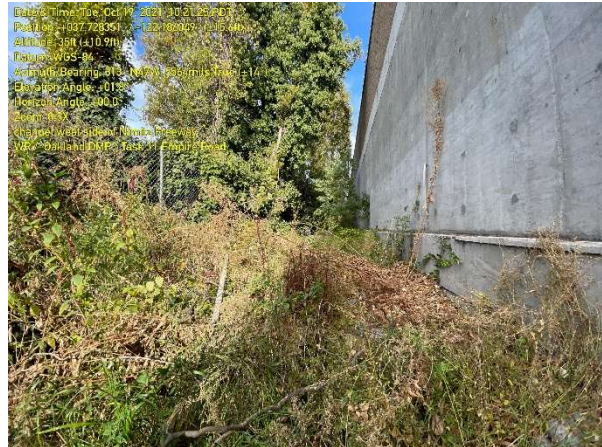
Photo 2: Channel parallel to I-880

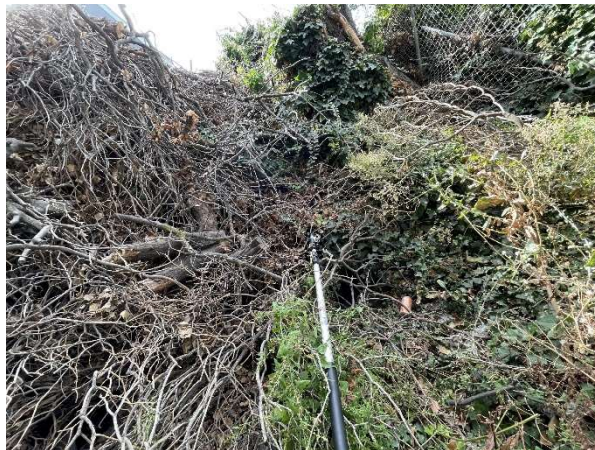
Photo 3: Channel outlet to 27" RCP pipe system

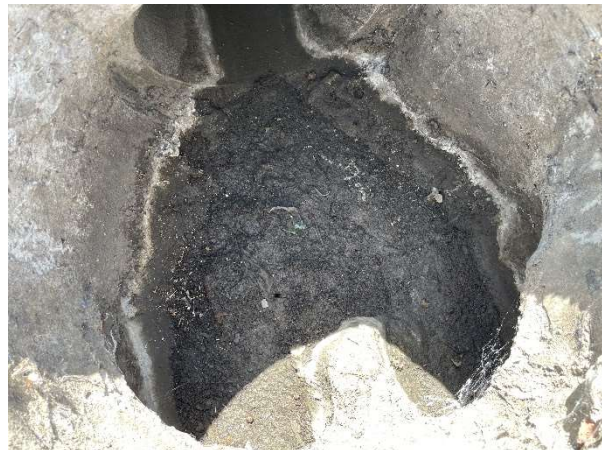
Photo 4: Dual 15" transition to single 18" under I-880

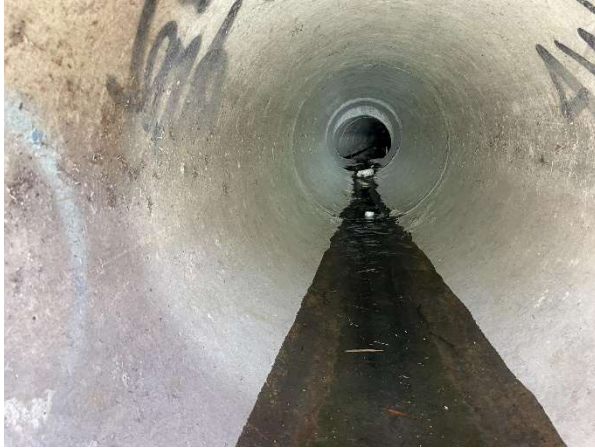
to access and does not receive routine maintenance resulting in severe overgrowth of vegetation, which reduces the conveyance ability of the system. The open channel terminates at a 27" RCP shown in Photo 5. The 27" RCP is in a good condition but was found to have 1 inch of sediment near Empire Road. The 27" RCP outfalls to San Leandro Creek as shown in Photo 6 and does not have a flap gate.

Photo 5: 27" RCP pipe to outfall

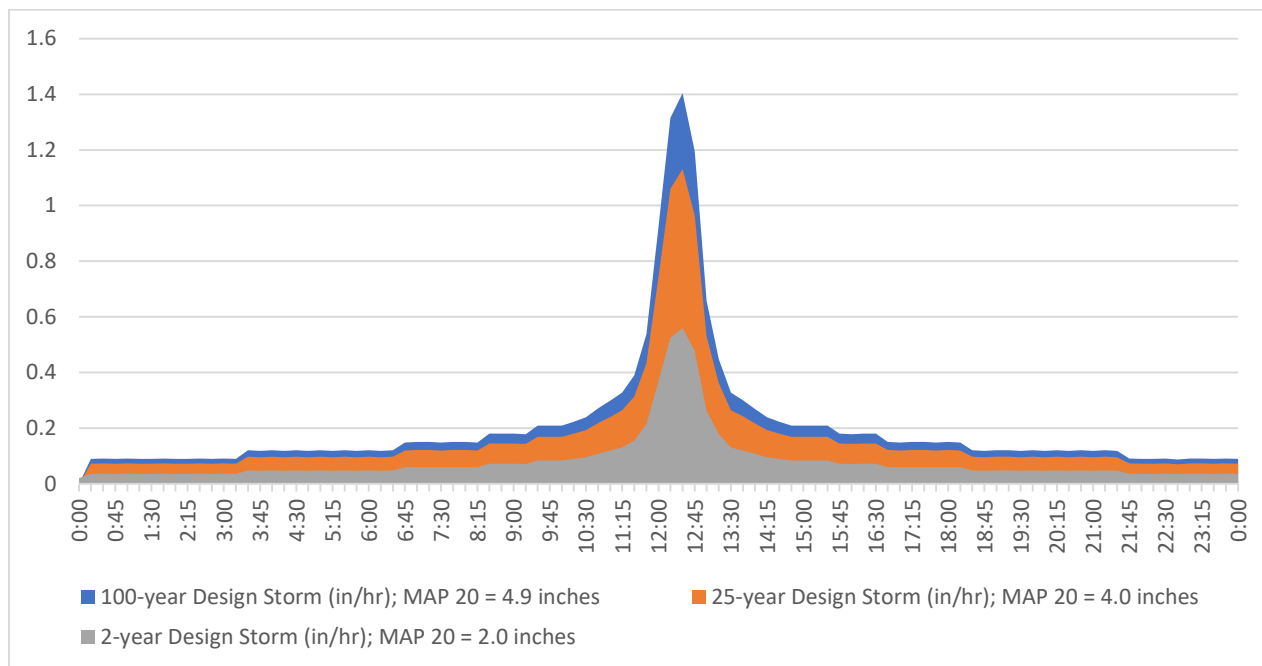
Figure 27 – 2018 ACPWA H&H Design Storms

The design storm in the *Alameda County Hydrology & Hydraulics Manual*, 2018, Alameda County Flood Control and Water Conservation District (2018 ACPWA H&H) was used for the hydrologic modeling of this study. See **Figure 27** for the 2018 ACPWA H&H design storms in a 15-minute interval and 24-hour duration.

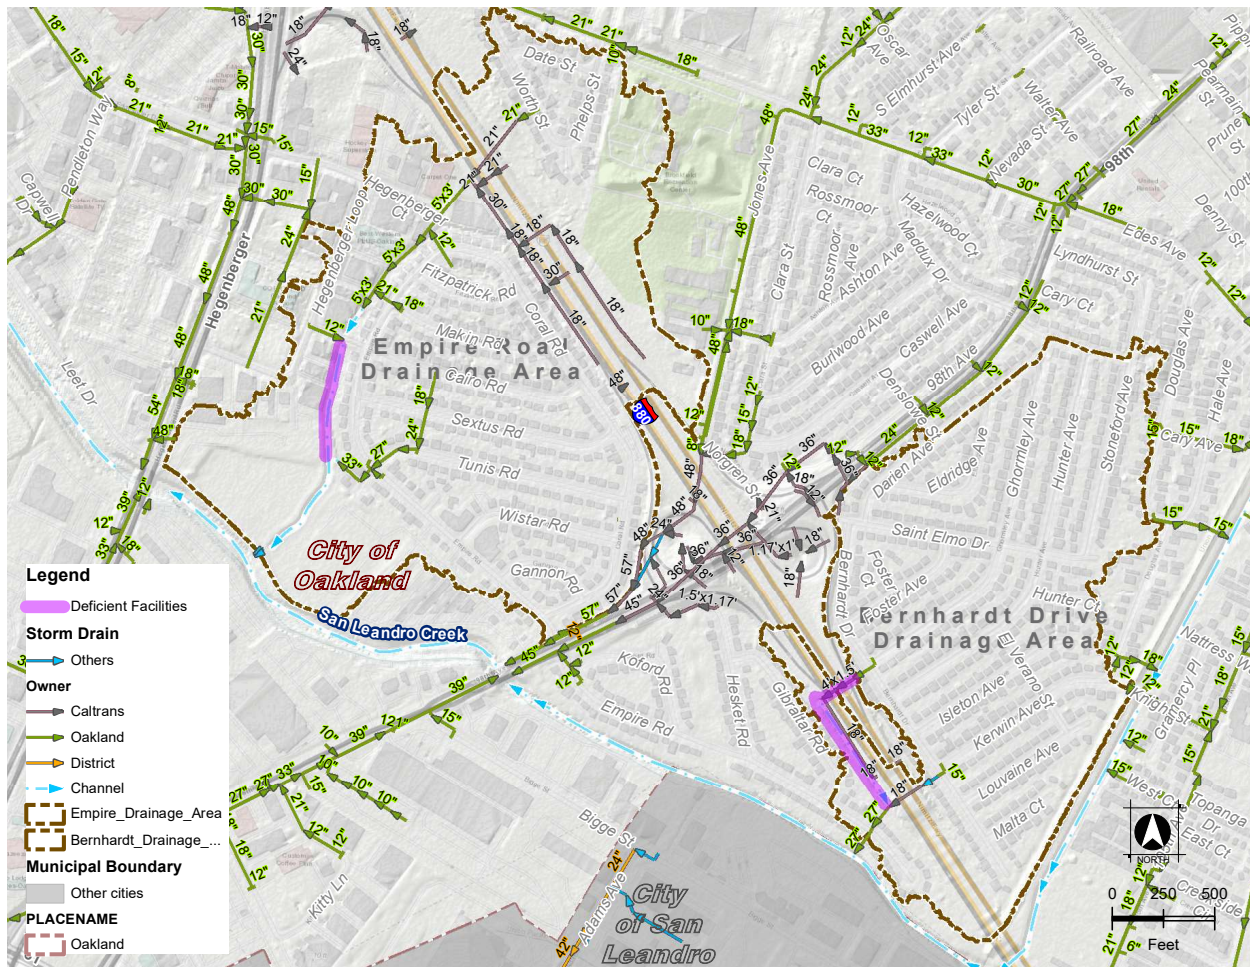
Figure 33 – Drainage Facilities Deficiency Map

The deficient drainage facilities are shown in **Figure 33** below.

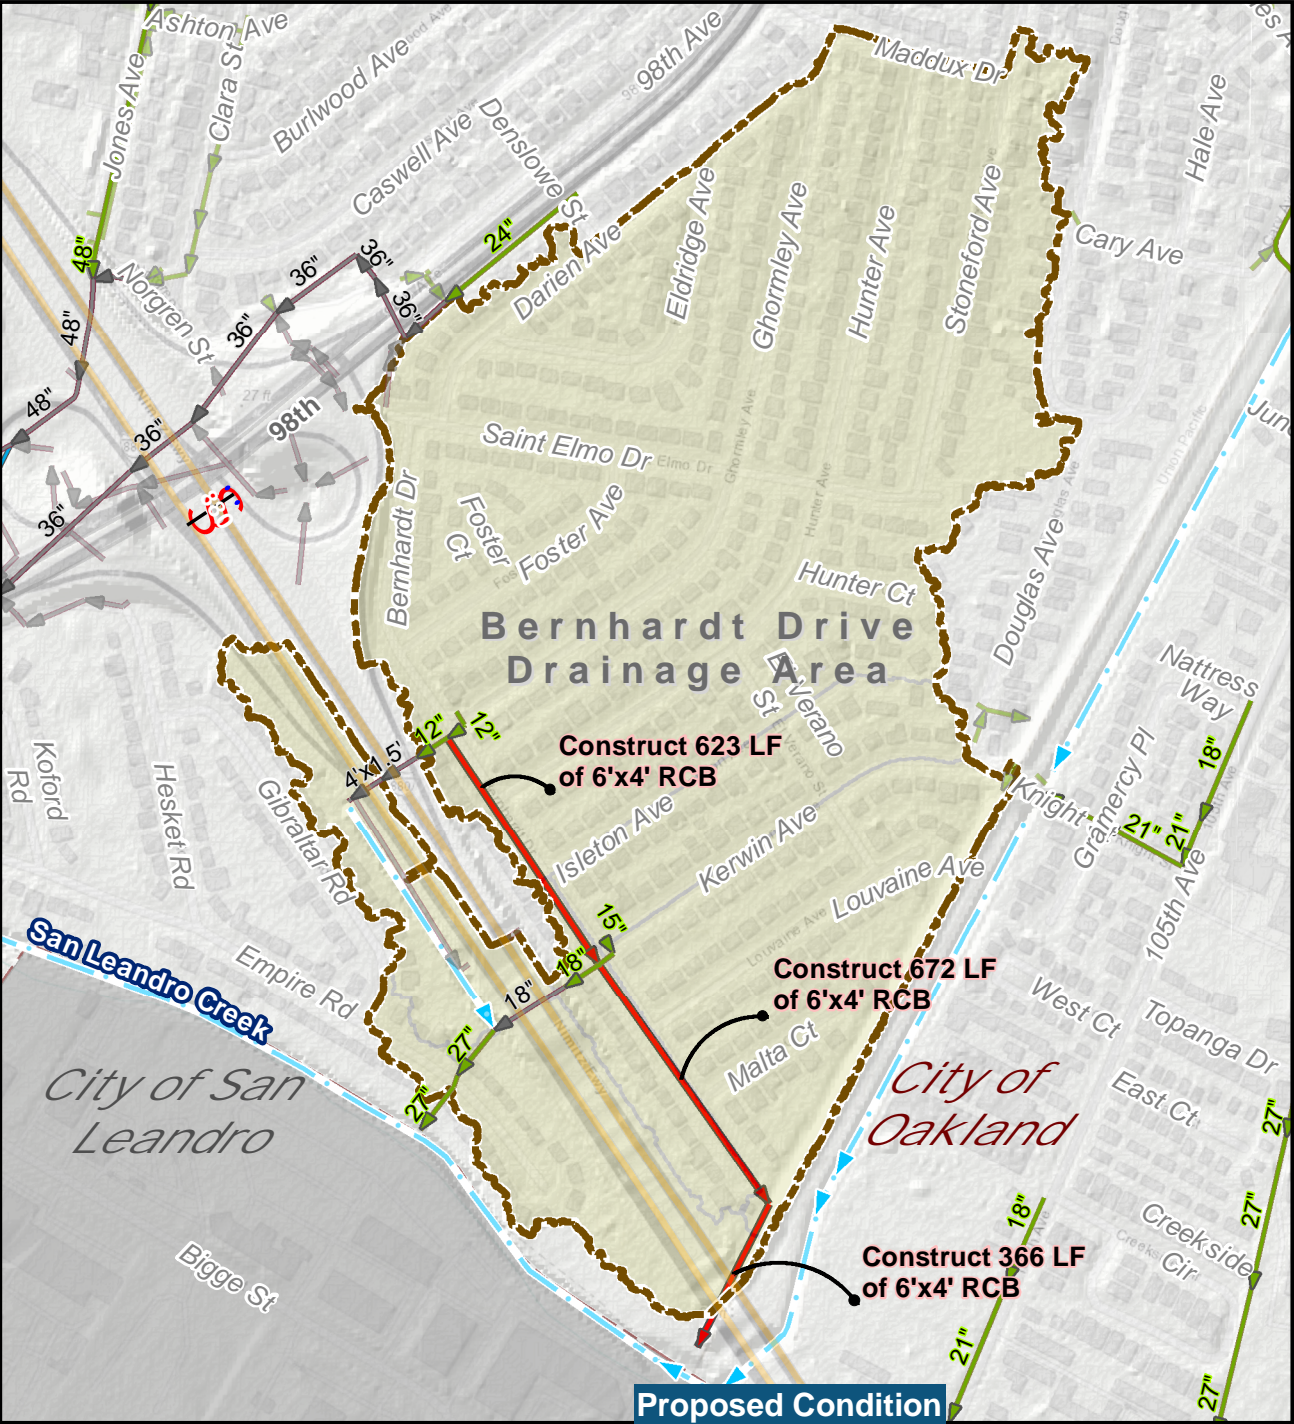
**Bernhart Drive Drainage
System 25-year Floodplain
and Improvement Map**

Deficient System	Proposed Improvements	Capital Costs (\$)	Total Project Capital Cost (\$)	Project Life Cycle Costs (\$)
Bernhardt Drive - Alternative 1	1,660 LF of 6'x4' RCB	4,510,000	4,702,000	4,872,000
	370 LF x 25 LF UPRR easement	92,000		
	Outfall structure	100,000

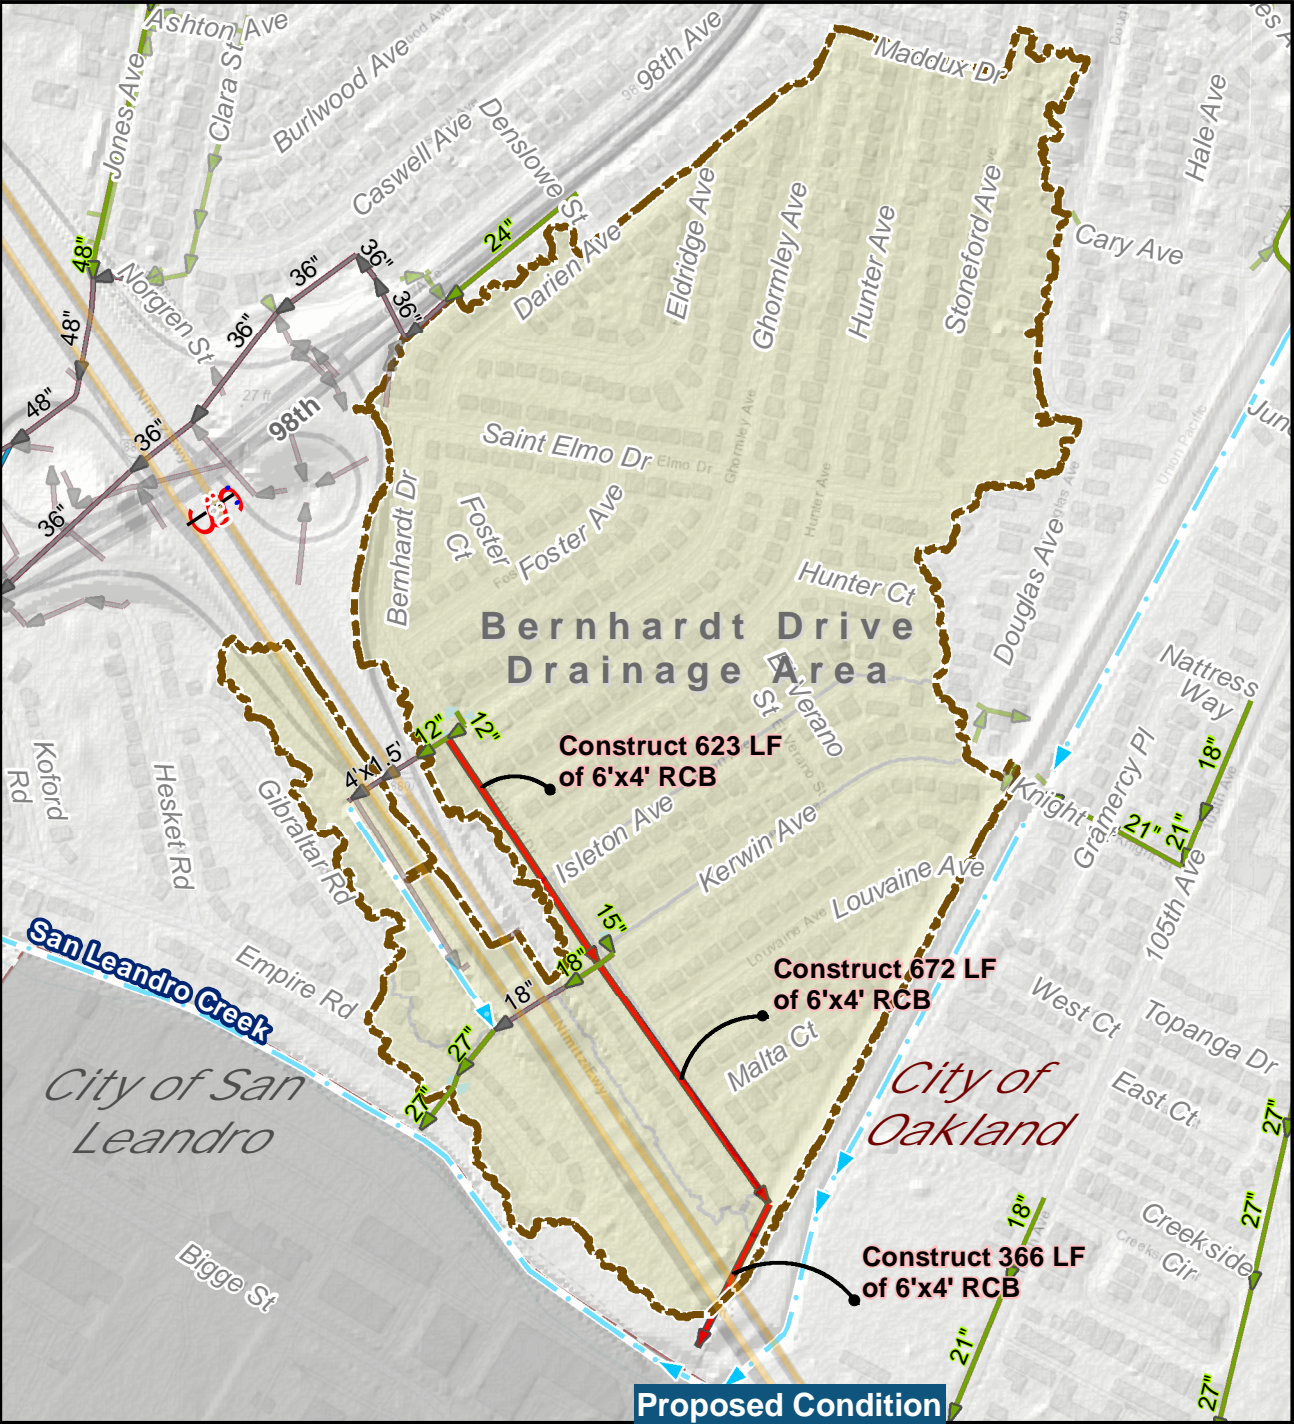
EXHIBIT C2

City of Oakland
Drainage Master Plan
**Bernhardt Drive Drainage
System 100-year
Floodplain and
Improvement Map**
Alameda County, California
June 2022

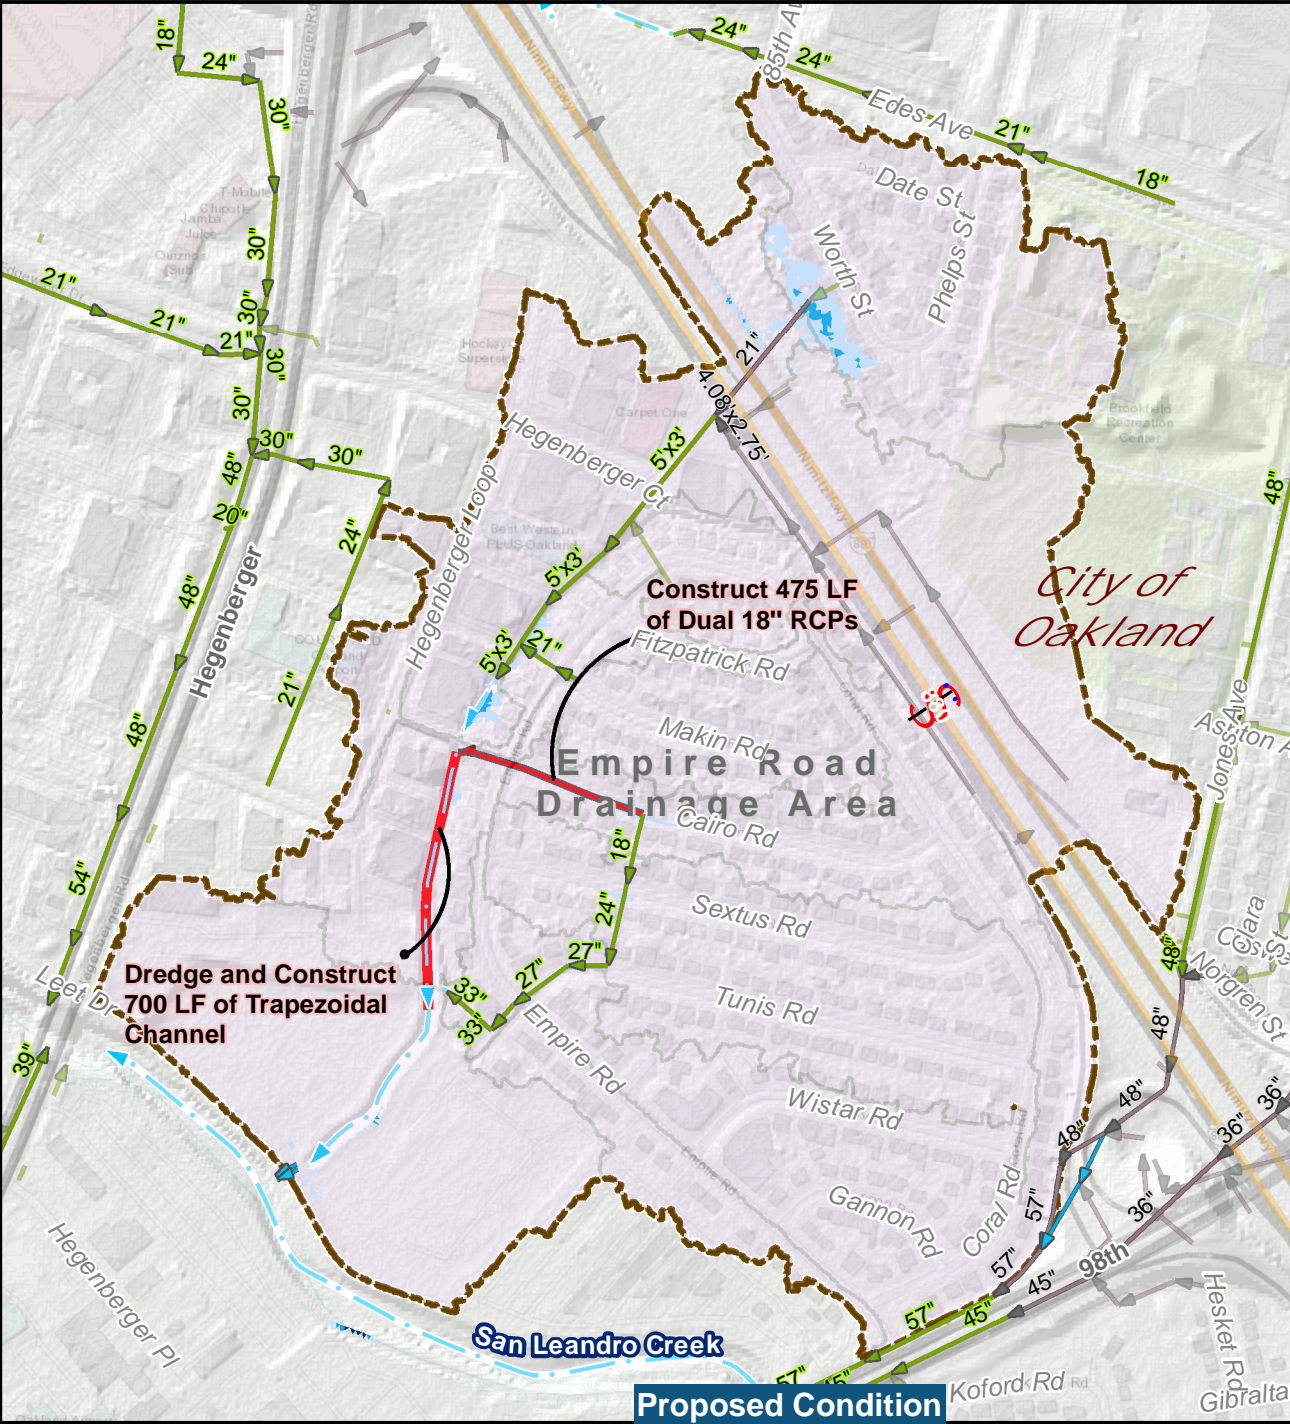
**Empire Road Drainage
System 25-year Floodplain
and Improvement Map**

Deficient System	Proposed Improvements	Capital Costs (\$)	Total Project Capital Cost (\$)	Project Life Cycle Costs (\$)	Annualized Project Life Cycle Cost (\$)
Empire Road - Alternative 1	475 LF of Dual 18" RCPs	691,000	1,409,000	2,109,000	90,000
	700 LF of Trapezoidal Channel Dredging	718,000

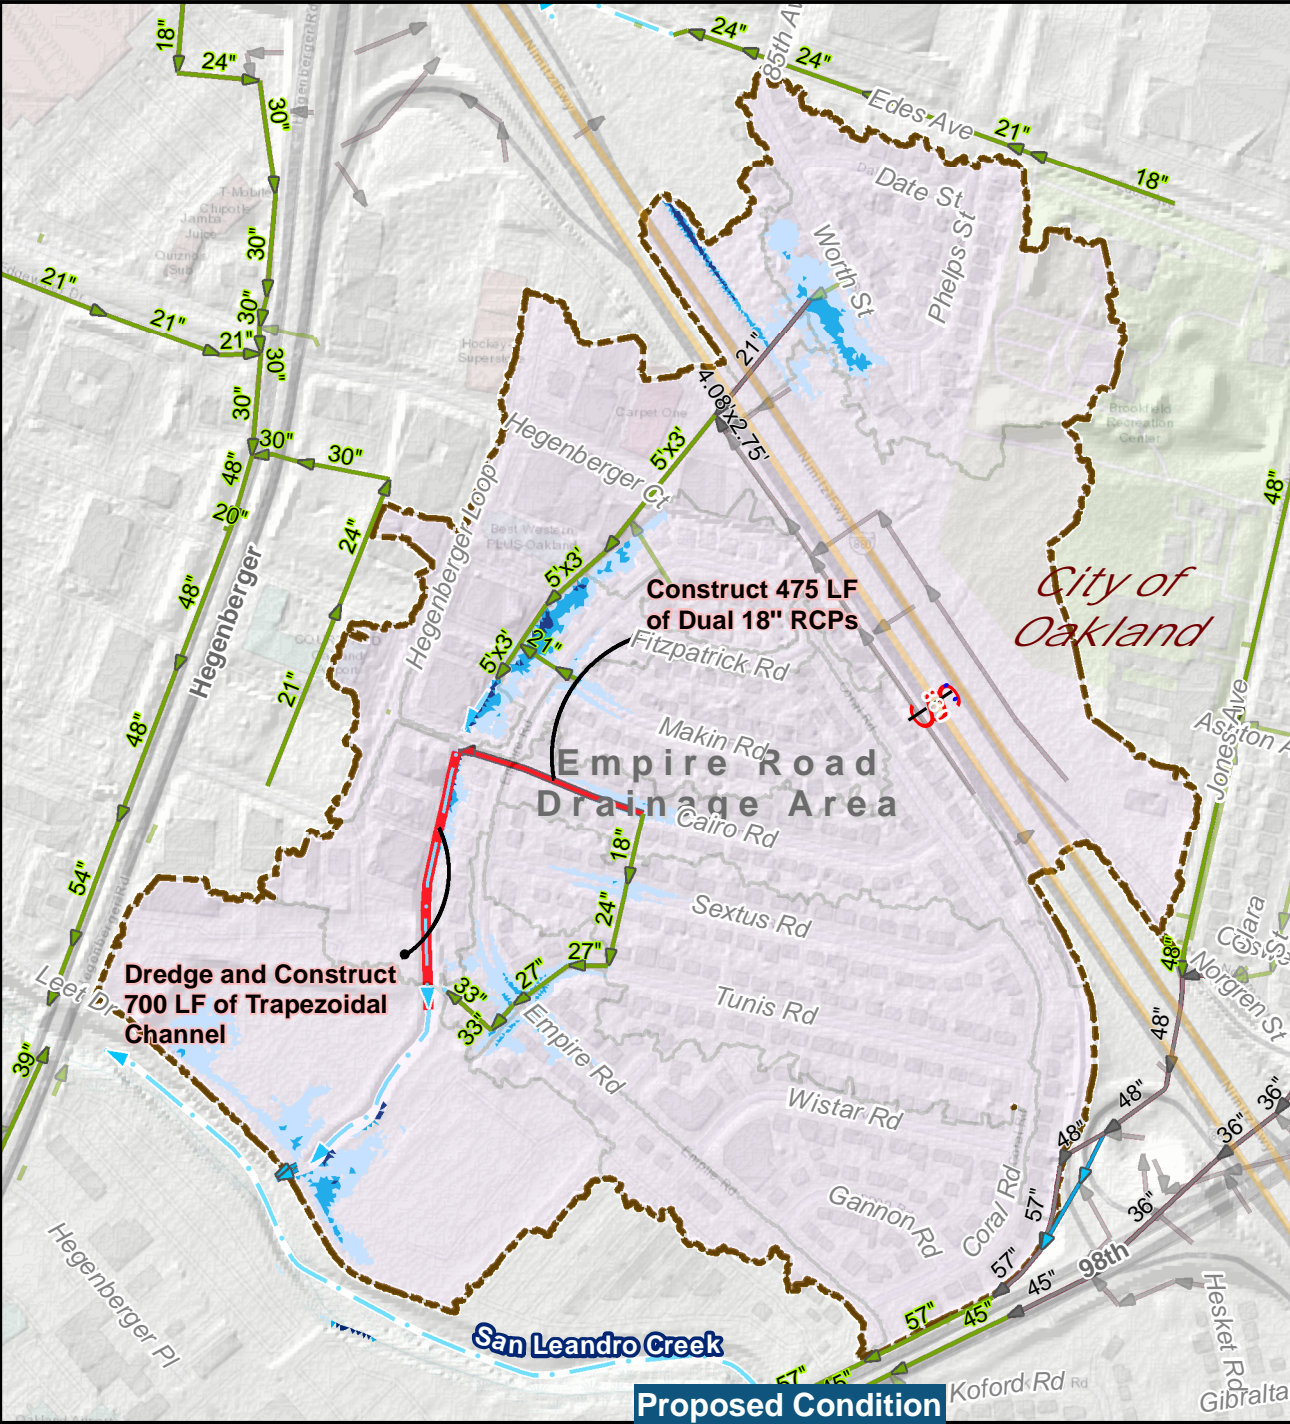
Empire Road Drainage
System 100-year
Floodplain and
Improvement Map
