MEMORANDUM

Re: Ney Avenue Neighborhood Traffic Calming Study Existing Conditions

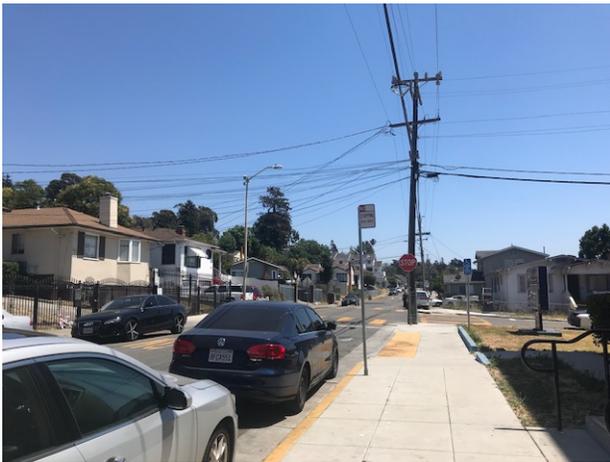
Figure 11: Curb Restrictions at Parker Elementary School

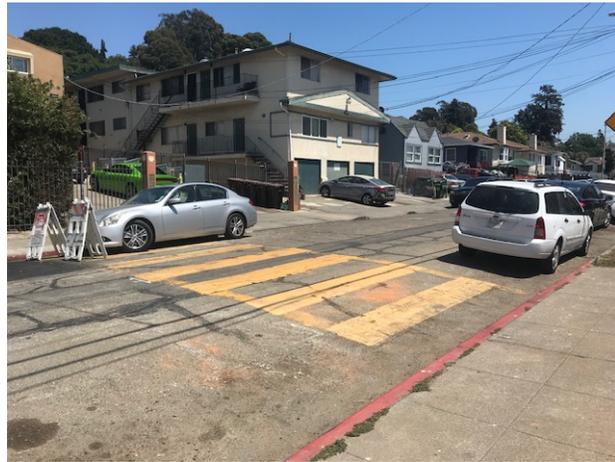
Figure 12: Mid-block Crossing at Parker Elementary School

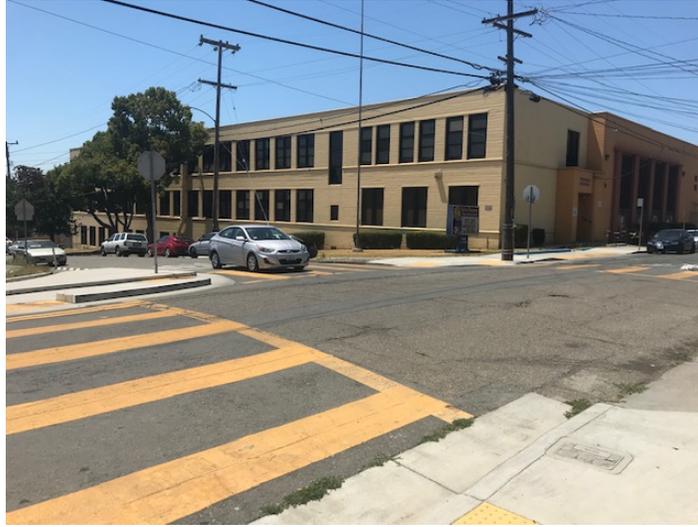
Figure 13: Southeast Corner at Ney Avenue and Ritchie Street with Recent Pedestrian Improvements

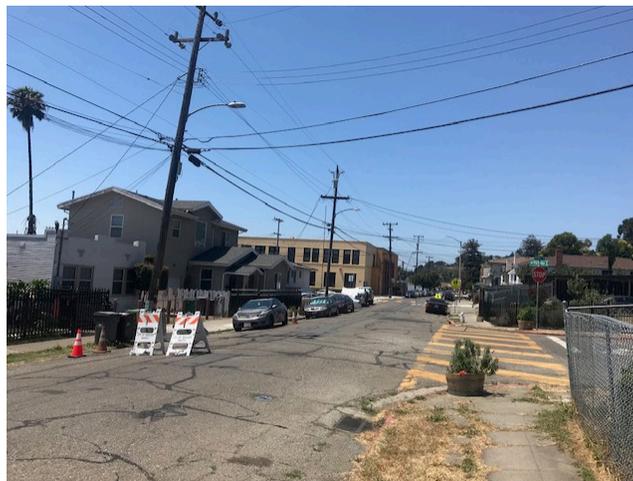
Figure 14: Southeast Corner at Ney Avenue and Partridge Avenue

At the intersection of Ney Avenue and Partridge Street, Partridge Street is stop controlled while Ney runs free. A stop bar and yellow continental marked crosswalk run across Partridge Street. Curb ramps are missing at the intersection. The northeast corner has a wide curb radius. There are storm drains on the northeast, northwest, and southeast corners in addition to a fire hydrant on the northwest corner. There is red curb at the northeast and southeast corner.

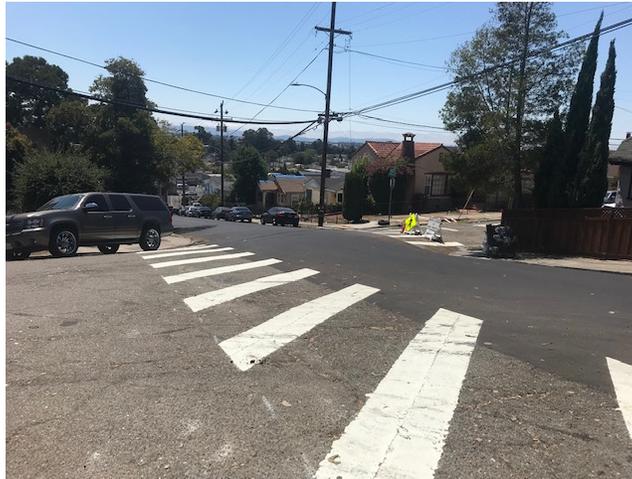
Figure 15: Continental Marked Crosswalk a Northwest Corner at Ney Avenue and Partridge Avenue

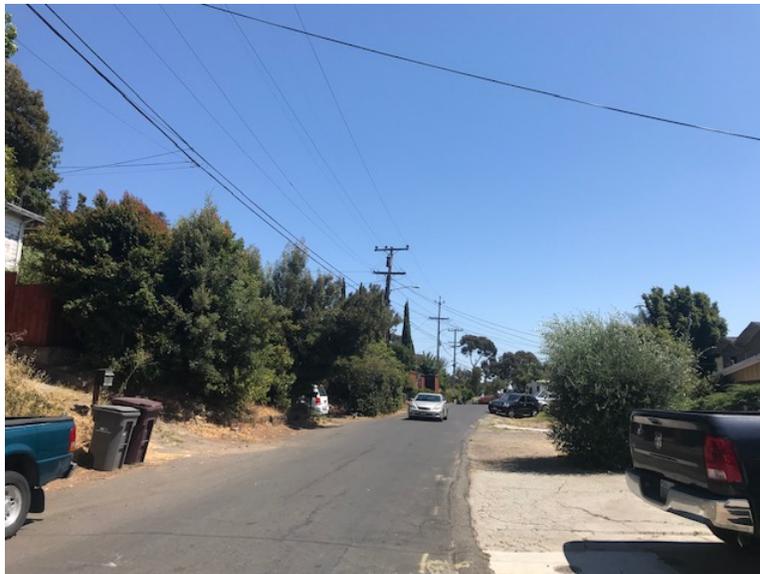
Figure 22: Hillmont Avenue Between 73rd Avenue and 75th Avenue Looking Southbound

This segment is approximately 550 feet long with a curb-to-curb width that ranges between 19 and 20 feet. Due to spatial restrictions, there are no defined parking spots. Alta staff noted that cars were parked partially on the street and on paved or grassy frontage space. There were six parked cars during the field visit. There are manholes at 7312 and 7405 Hillmont Avenue. Speed humps are not installed in this section.

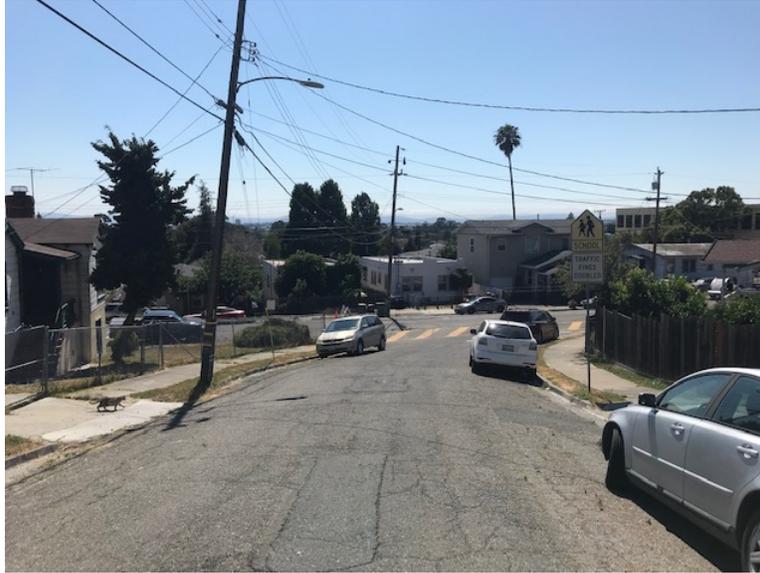
Figure 30: Partridge Avenue Between Ney Avenue and Hillmont Drive Westbound

Partridge Avenue, between Ney Avenue and Hillmont Drive, is approximately 800 feet long and ranges from 25 to 27 feet wide. Partridge Avenue crosses Outlook Avenue approximately 400 feet East of Ney Avenue. Outlook Avenue is a short no outlet street that has access to a few residencies. During the field visit 28 of the approximate 60 parking spaces were being utilized. The gutter pan width along this segment ranges from 22 to 24 inches. Alta staff noted that some vehicles were partially parked on the sidewalk. There is a manhole and a storm drain at 3022 Partridge Avenue, as well as, a utility cover at 3034 Partridge Avenue. Partridge Avenue begins a steep incline as it travels east from Ney Avenue to Hillmont Drive.

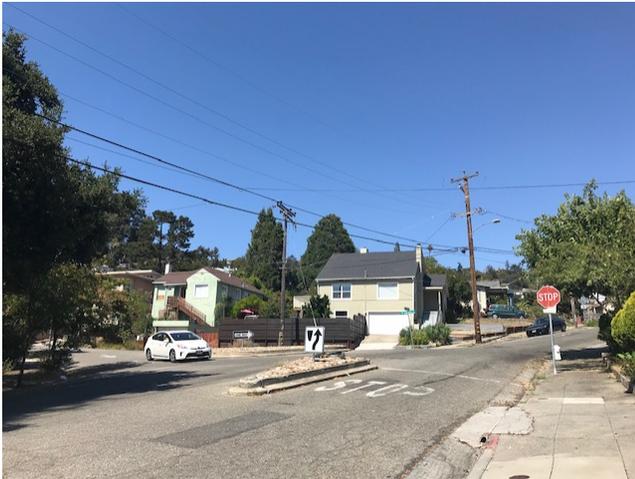
Figure 32: Southeast Corner at Partridge Avenue and Hillmont Drive

Partridge Avenue at Hillmont Drive is a T- intersection with all-way stop control. Pork chop islands are installed on Hillmont Drive and on the west approach of Partridge Avenue. The pork chop island on Hillmont reduces the turning radius for vehicles traveling southwest. The pork chop island on Partridge Avenue prevents vehicles from turning left onto Hillmont Drive at that location. Each approach has fading stop bars and pavement marking. A fire hydrant is installed on the south corner of the intersection with red curb adjacent to the fire hydrant, as well as, along the curb in the intersection.

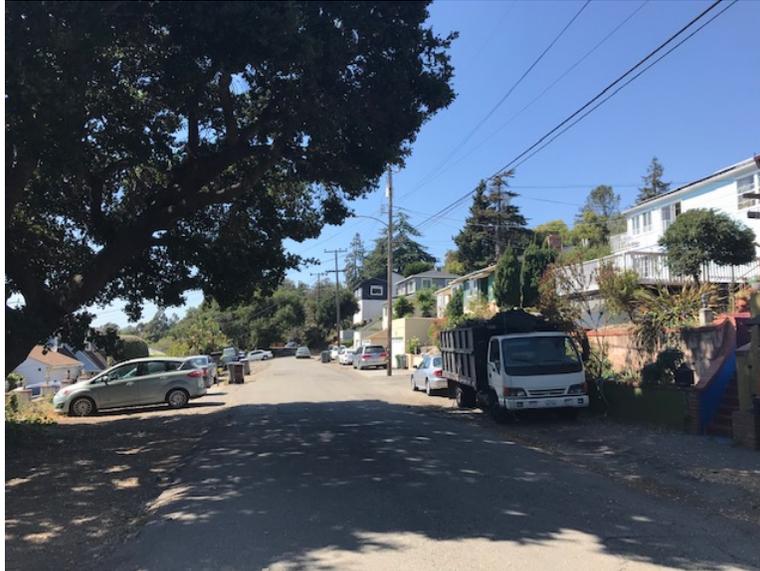
Figure 35: Hillmont Drive between Tully Place and Parker Avenue Northbound

Hillmont Drive between Tully Place and Parker Avenue is approximately 1150 feet and 20 feet wide, with a width of 15 feet at its narrowest point. The block does not have curb and there is not a formal sidewalk or parking. During the field visit there were 11 cars parked; most were parked partially on property. There are storm drains at 7932 and 2893 Hillmont Drive, manholes at 7776, 7843, and 7915 Hillmont Drive, and utilities at 7762, 7832, 7800, and 7864 Hillmont Drive.
