Project Location:	1000 Oak Street (Oakland Museum of California)
Assessor's Parcel Numbers:	018 045000400
Proposal:	Alterations to the Oakland Museum of California property that consist of on-site landscaping replacement, and exterior façade improvements to portions of the north and south building facades to improve accessibility and visibility of the facility.
Project Applicant/ Telephone:	Suzanne Brown / (415) 577-3723
Property Owner:	City of Oakland
Case File Number:	ZP180120
General Plan:	Central Business District
Specific Plan:	Lake Merritt Station Area District
Zoning:	D-LM-4 Lake Merritt Station Area District Mixed Commercial
Environmental Determination:	CEQA Exempt per Sections 15301-Existing Buildings; and 15303 Minor Alterations.
Property Historic Status:	OCHS A1+, Designated Historic Property API, Area of Primary Importance (Lake Merritt)
City Council District:	3
For Further Information:	Contact Case Planner, Mike Rivera at (510) 238-6417, or by email at mriviera@oaklandnet.com

**OAK
LAND
MUSEUM
OF
CALIFORNIA**

HISTORIC RESOURCE EVALUATION REPORT

Prepared for
Oakland Museum of California

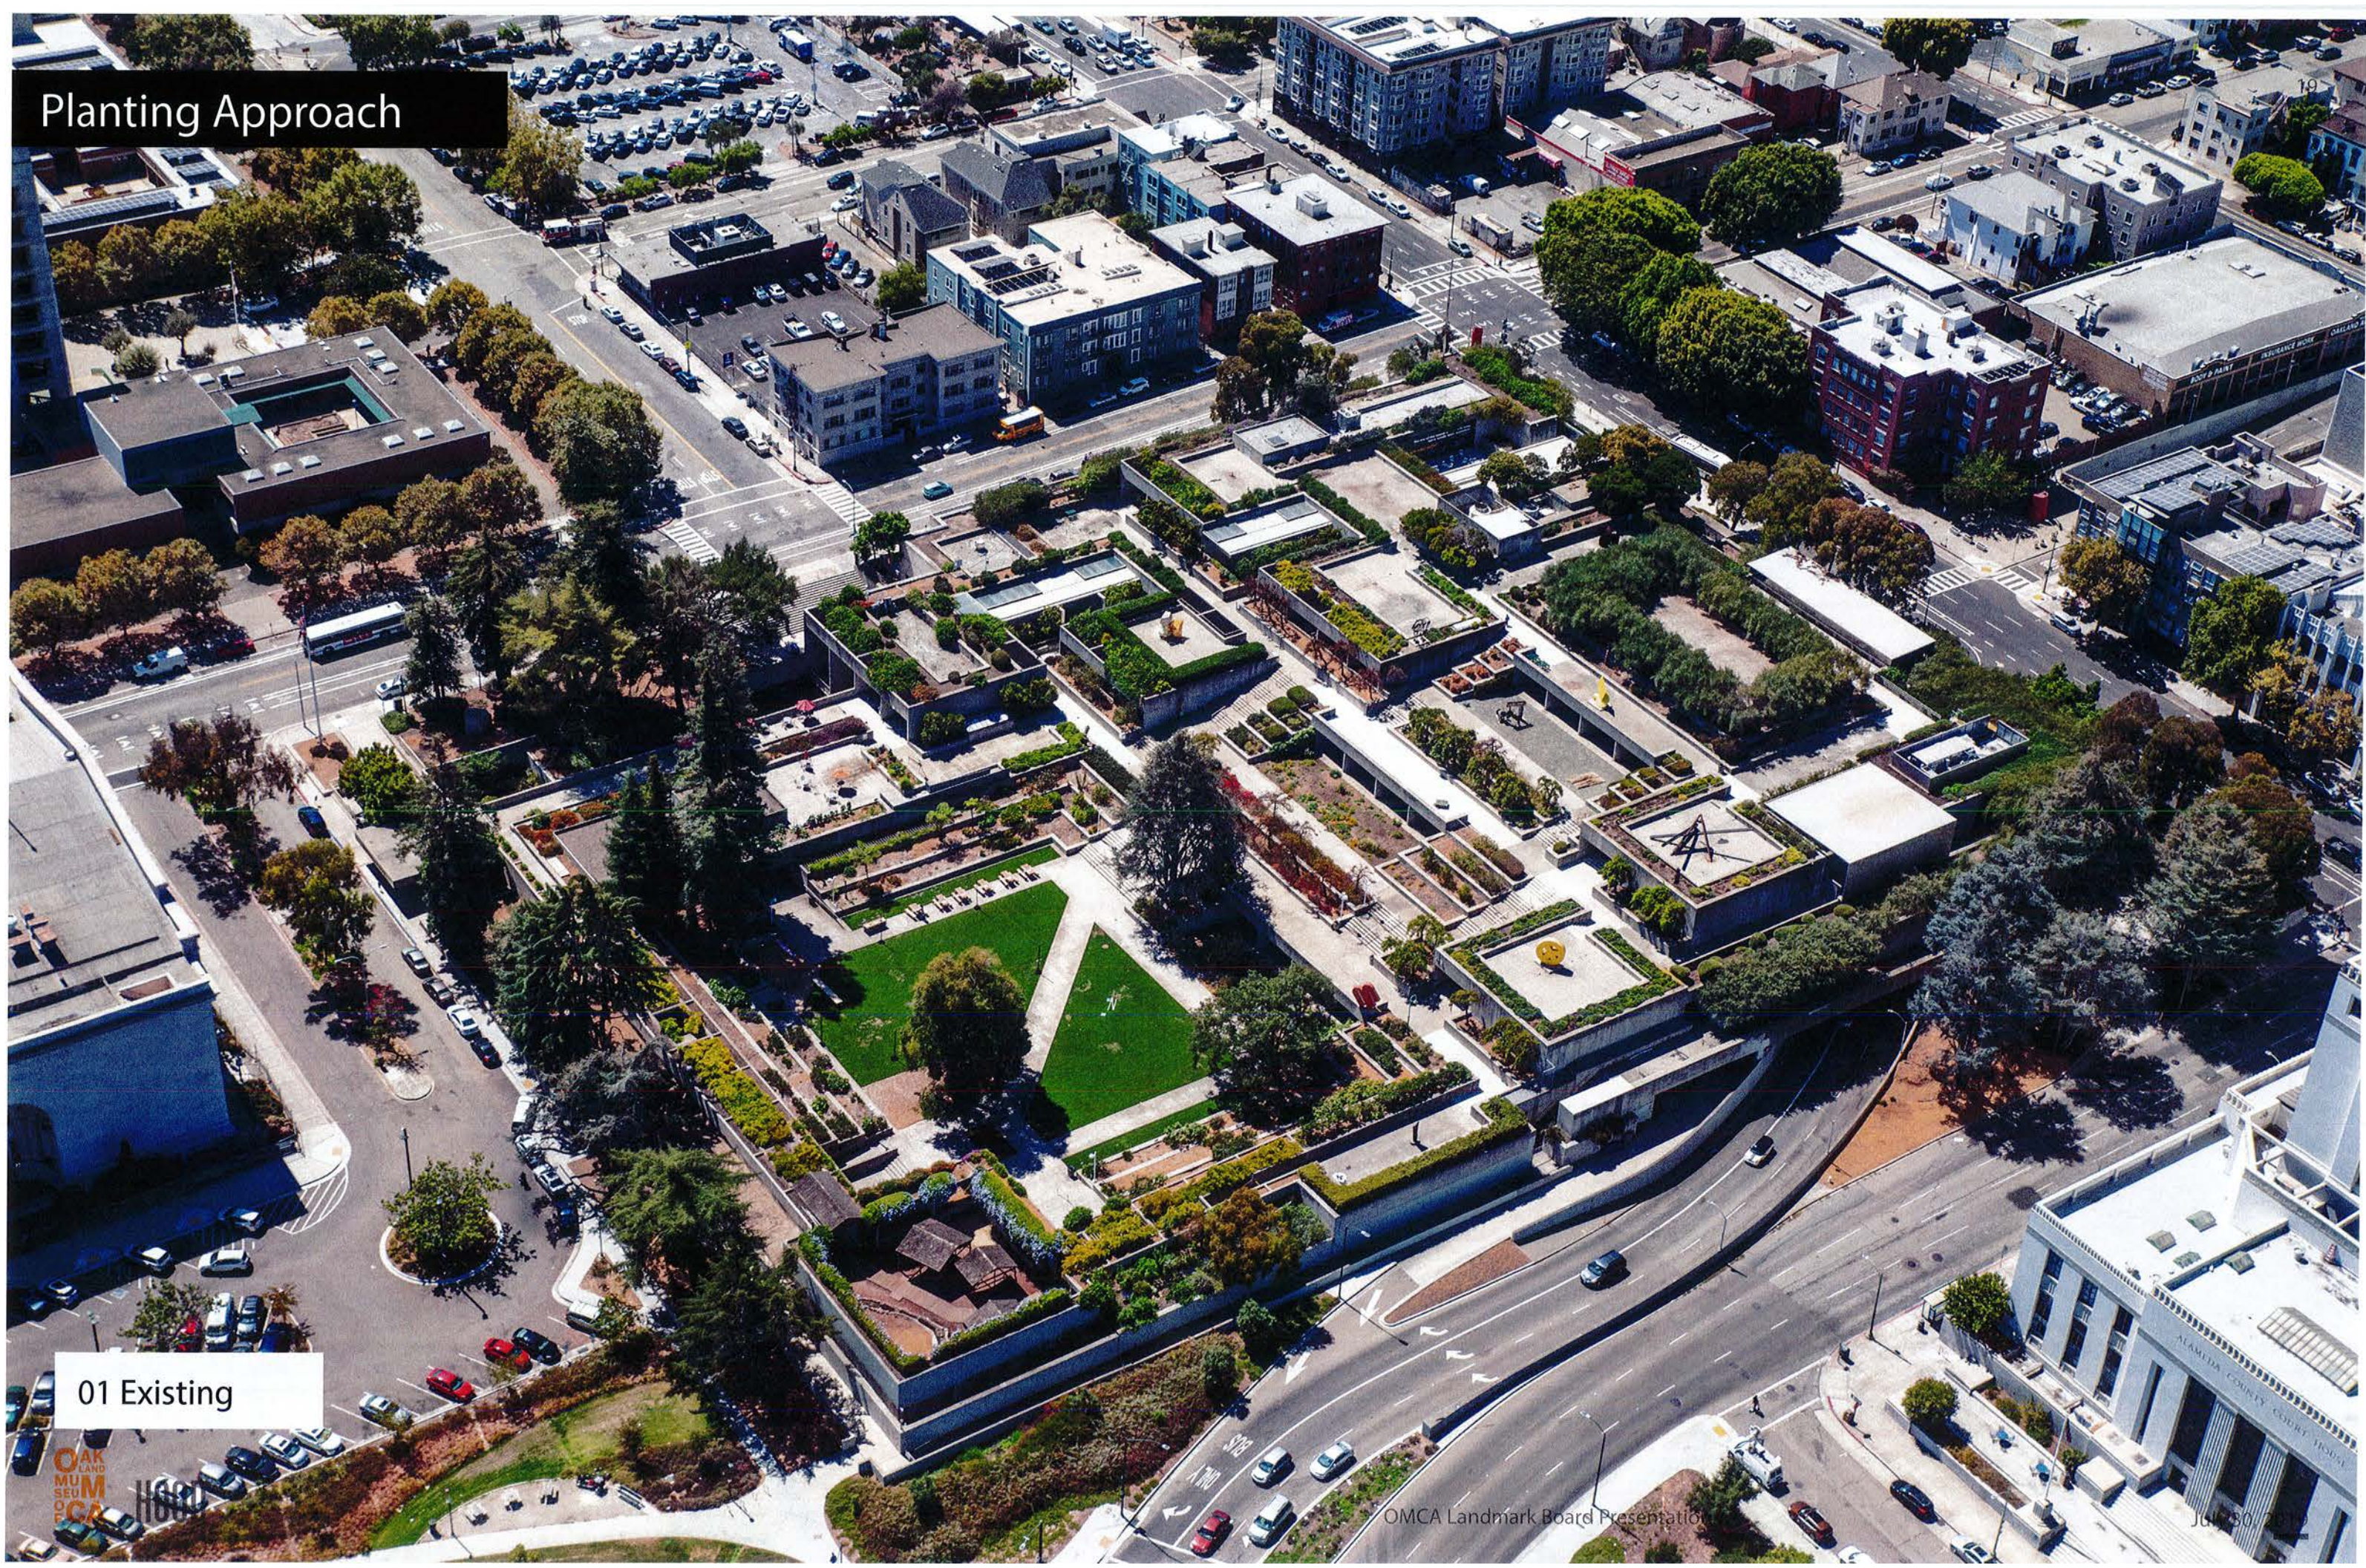
Planting Approach

Cross Section of California

Planting by Ecoregions

- The proposed garden design concept would introduce plantings that are commonly found in the following five ecological zones in California: coastal forest, low desert, Mediterranean, woodland, and coastal prairie.
- In select locations, planters and hardscape features would be modified to accommodate new architectural features.
