Location:	664 Haddon Road (Henry J. Kaiser Residence).
Assessor's Parcel Number:	023 043000100
Proposal:	Preliminary Determination of Landmark Designation Eligibility.
Property Owner:	Kaiser Foundation Health Plan, Inc.
Applicant/ Phone Number:	Nelson White and Stacy Farr, SWCA Environmental Consultants / (415) 536-2883
Case File Number:	LM19012
General Plan:	Detached Unit Residential
Zoning:	RD-1- Detached Unit Residential Zone
Environmental Determination:	Exempt per Section 15331 of the State CEQA Guidelines, Historical Resource Restoration/Rehabilitation; Section 15183 Projects consistent with the Community Plan, General Plan or Zoning.
Historic Status:	Current Oakland Cultural Heritage Survey rating: C1+ (C=Secondary importance; 1+ = contributor to the Haddon Hill Area of Primary Importance)
City Council District:	2
Action to be Taken:	Preliminary Determination that the property meets the Landmark designation criteria.

Address: 664 Haddon Road (Henry J. Kaiser Residence)

HISTORICAL RESOURCE EVALUATION FOR 664 HADDON ROAD, CITY OF OAKLAND, COUNTY OF ALAMEDA, CALIFORNIA

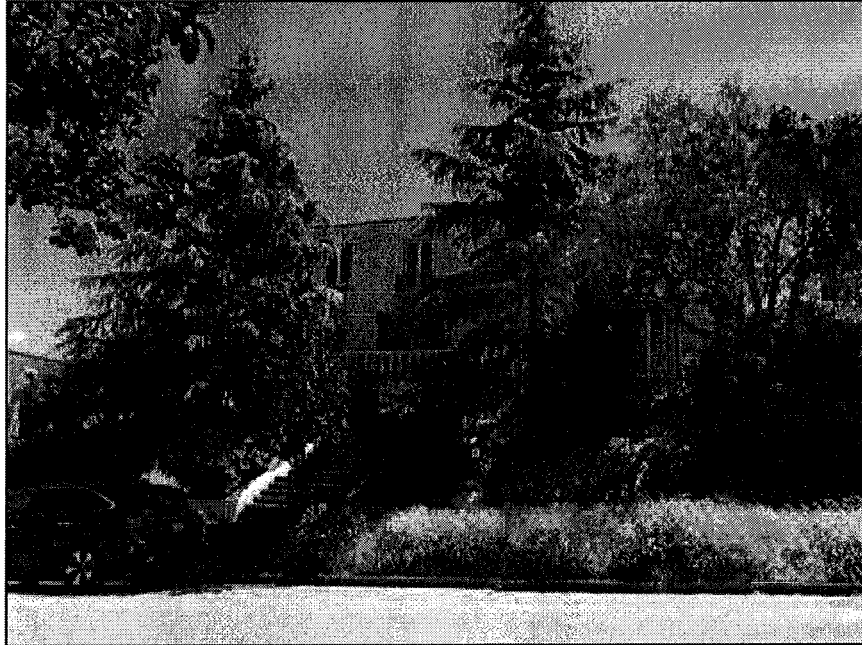
Figure 4. Overview of primary (west) façade at 664 Haddon Road, view east (SWCA, 2018).

The second-floor level of the primary (west) façade continues the largely symmetrical arrangement found at the first-floor level. At center, above the primary entrance, there are full-height, three-lite French casement windows which open onto a small balcony with a wrought-iron railing and balustrade (Figure 12). This central window is flanked at the second-floor level by two pairs of three-lite French casement windows, which are slightly recessed within the thickness of the façade with exaggerated sills.

At far left, the second-floor level includes three, arched, six-lite casement windows, trimmed together with wood molding which gives the appearance of engaged pilasters, and with simple raised circular moldings within their spandrel panels (Figure 13). This same window arrangement is repeated at the far right of the second-floor level. The corners of the second story feature a beveled profile. The primary façade terminates with a molded cornice and moderate eave overhang; there are wood ball-cap finials at the roof corners.

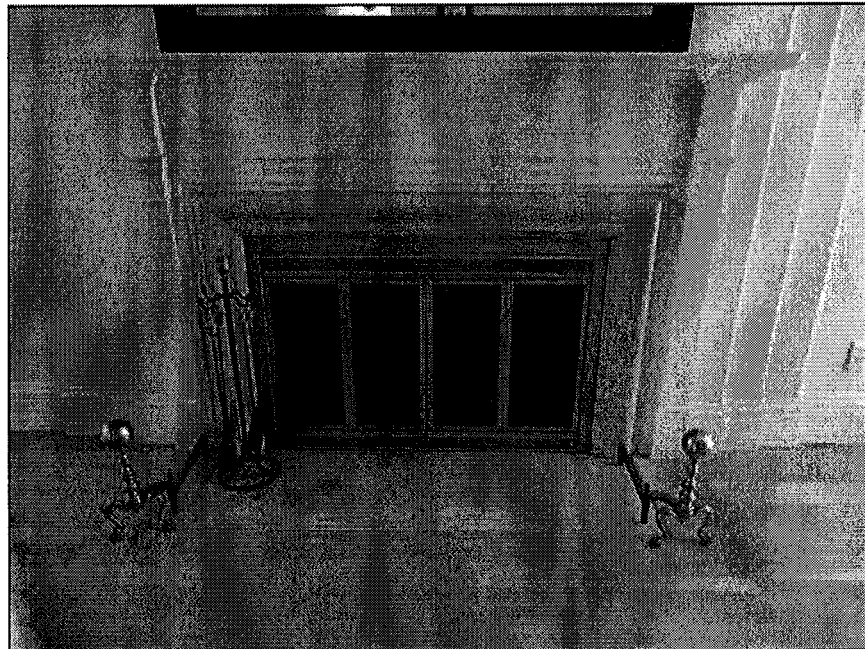
Figure 34. Detail of fireplace, view north (SWCA, 2018).

The living room is located to the left (north) of the foyer and is lit on three sides by full-height arched windows (Figure 33). A fireplace at the north wall is built out from the wall with a stepped profile, and is framed by stone and has a wood mantle (Figure 34). The room has crown moldings, which continue throughout the house unless otherwise noted, and typical flooring and baseboards, though ventilation grates are located above, rather than at, the baseboards in this room.
